Damp Specialist Findings and suggested Solutions:

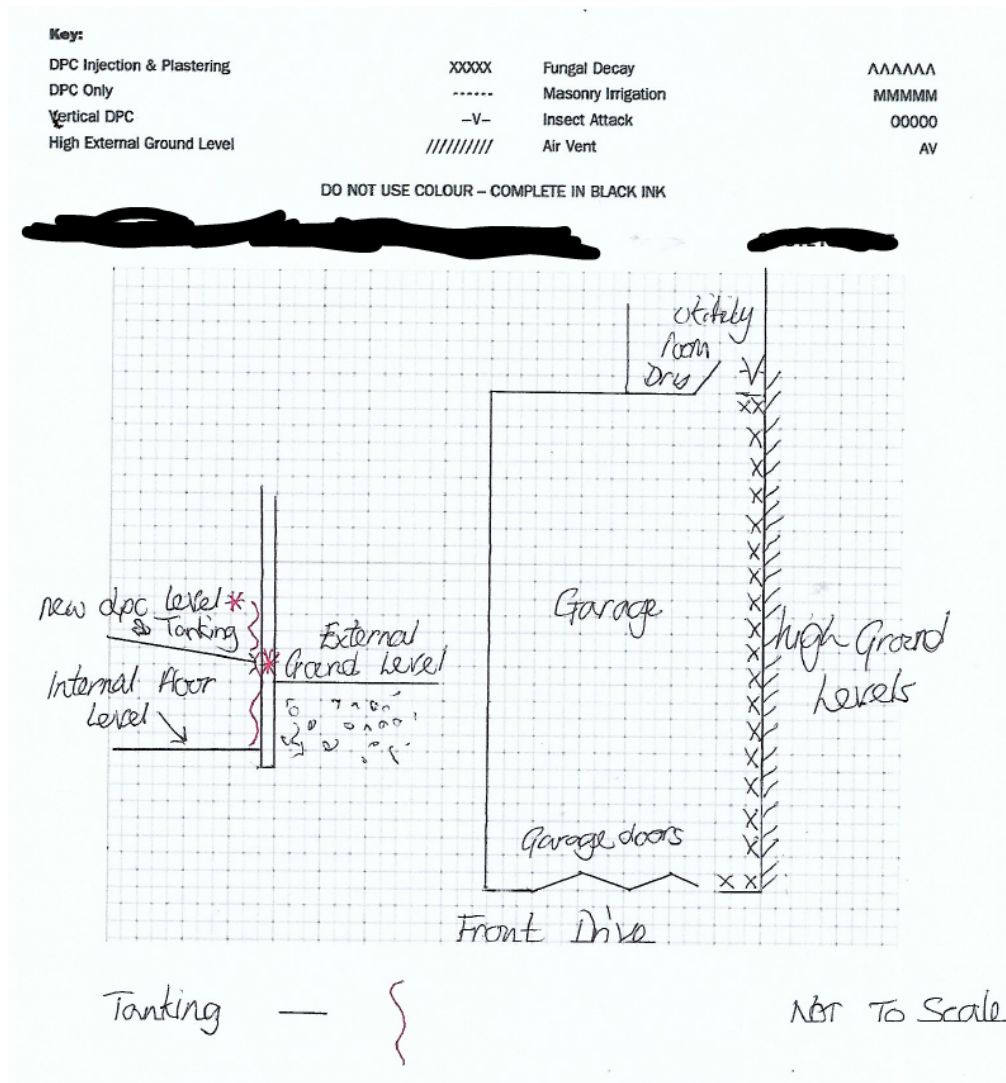
108 reading in utility room at back of garage (new extension)

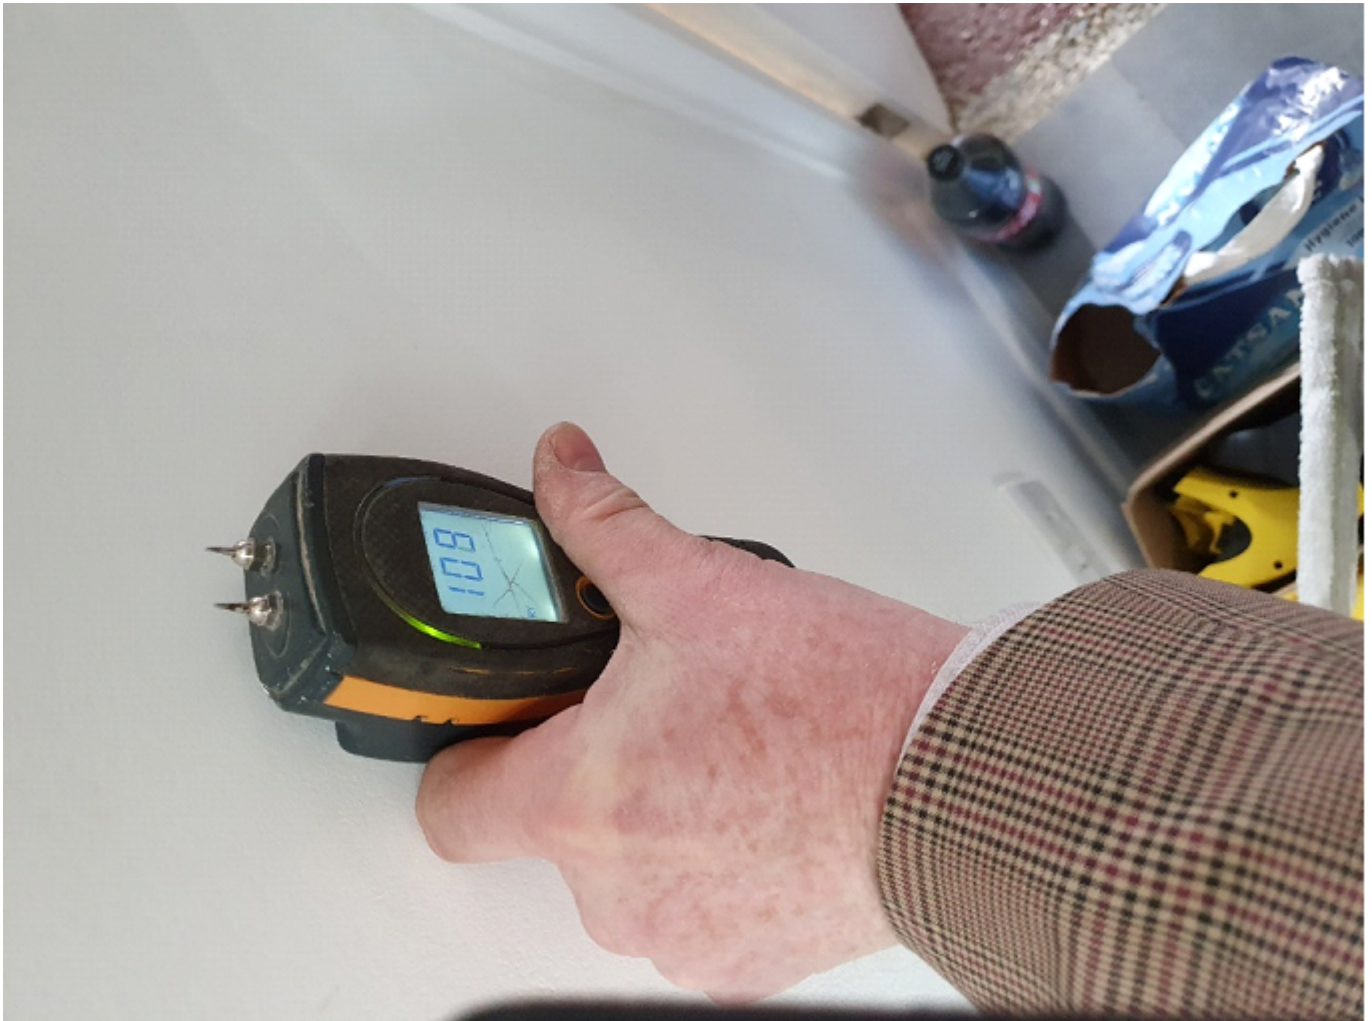
Garage wall

High moisture readings to the side garage external wall this has been caused by the high external ground levels to the neighbors adjoining wall, the neighbors garage roof is also sloping towards the property and does not look like the wall has been protected properly, I understand this is being addressed by a roofer who was on site when I visited the property, the internal wall in the garage will need damp proofing by raising the new damp course and using tanking due to the high ground levels tanking is usually used in basements but due to the high ground levels it will be needed to damp proof this wall, moisture readings were taken throughout the living areas of the property and no high moisture readings were found, I will attach separately photographs of the readings found.

To be carried out as per our treatment method for rising and penetrating damp as shown on the plan of works, we will need to raise the new damp course and apply tanking at low level.

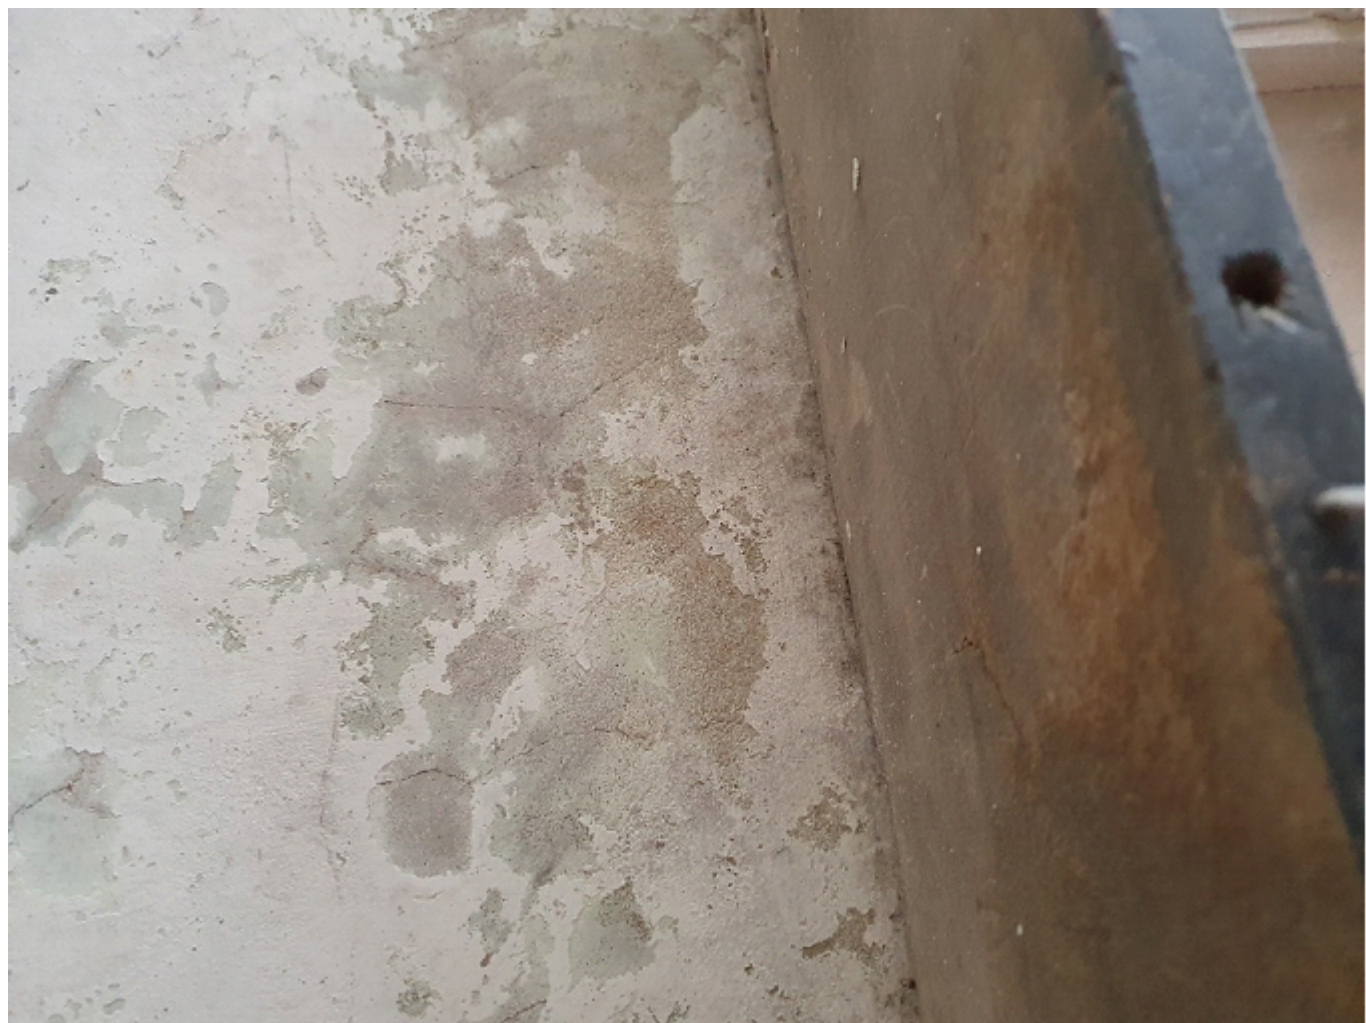
High reading at front of garage.
