- A Introduction to the report
- B About the inspection
- C Overall opinion and summary of the condition ratings
- D About the property
- E Outside the property
- F Inside the property
- G Services
- H Grounds (including shared areas for flats)
- I Issues for your legal advisers
- J Risks
- K Surveyor's declaration
- What to do now
- Description of the RICS HomeBuyer (Survey) Service
- Typical house diagram

21 Rounds Road, Bilston, West Midlands, WV14 8TD

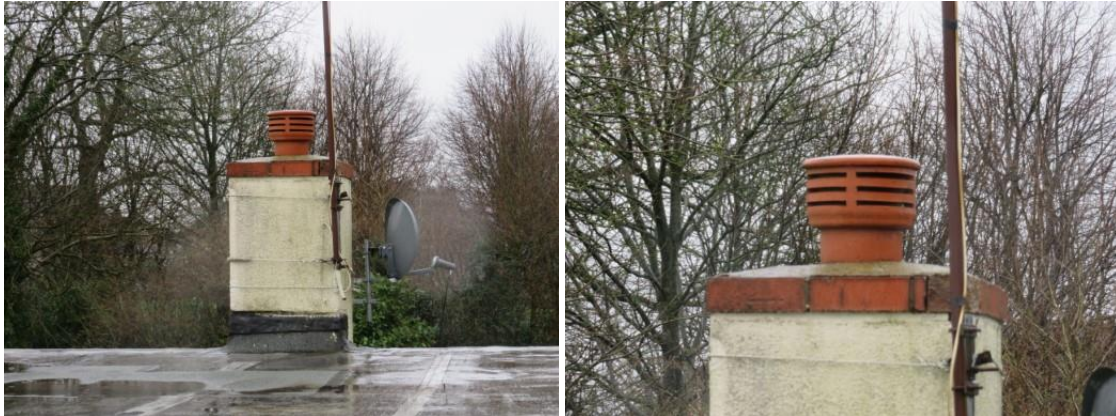
The chimney stack was examined from ground level with the aid of binoculars, and a camera on an extended pole, for possible defects including undue movement, distortion, chemical or weather-related damage, brickwork, render and pointing damage and other evidence of failure.

No significant defects were noted, and the chimney stack was found to be structurally stable.

(Condition Rating 2).

The chimney stack should be regularly monitored for any indications of damage, instability or other defects. You should carry out a thorough visual inspection at least once a year, ideally in the Spring, and ideally at roof level, to identify and repair any damage that could have been caused by winter weather. Missing, loose or defective mortar should be repointed as necessary.

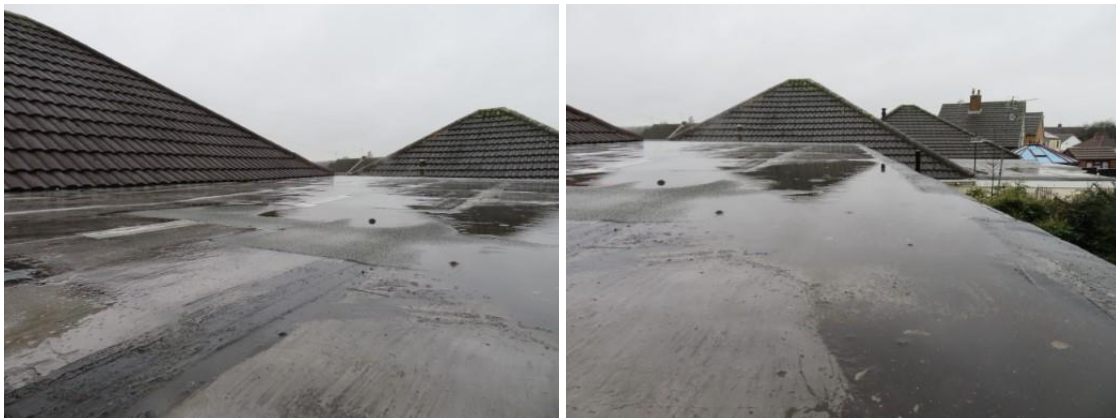
The rear extension has a flat roof covering. A solar reflective paint has been applied. The underside of the roof covering is concealed, but I could not see a leak internally on the ceiling.

There is evidence of previous repairs. I could see cracking and general degrading of the roof covering.

(Condition Rating 2).

Mineral felt roofs have limited life span (approximately 20 years) and are prone to sudden failure, therefore you should establish the age of the roof covering via your legal advisor in order that you may plan for future expenditure. (See Section I3). The flat roof will require replacing soon and you should obtain an indication of costs via an appropriately qualified person prior to exchange of contracts.

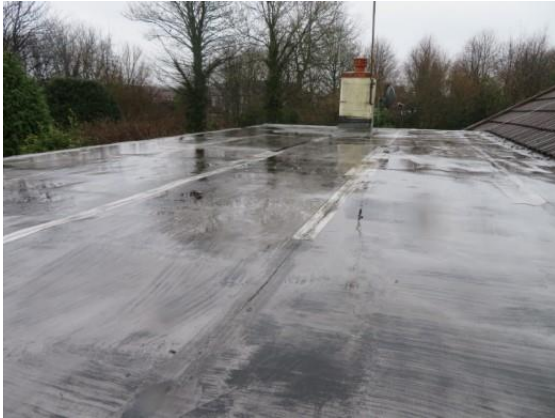
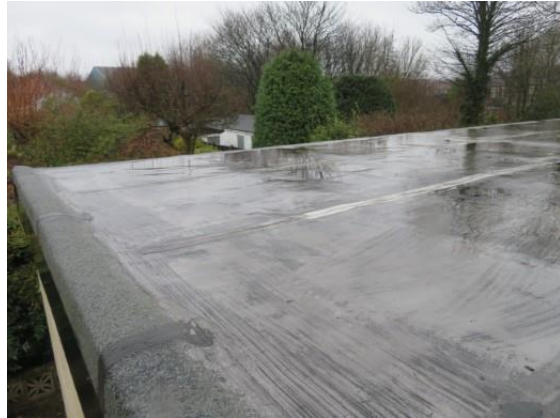
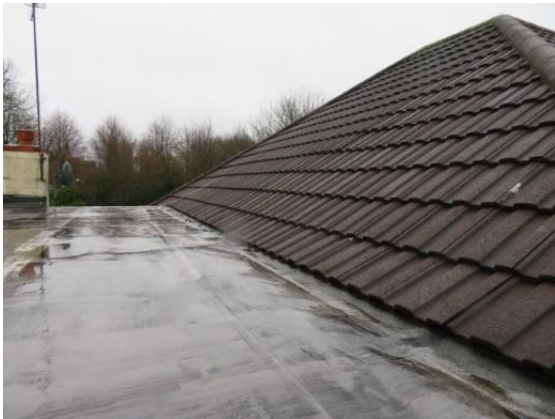
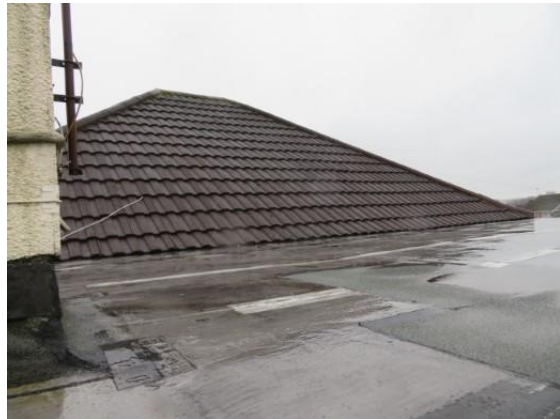
The bay windows are covered with mineral felt roof coverings with a lead drip. The underside of the roof covering is concealed, but I could not see a leak internally on the ceiling.

The roof coverings are similarly showing signs of wear. The dressing of the bay roof covering under the eaves on the left-hand bay window has become detached.

(Condition Rating 2).

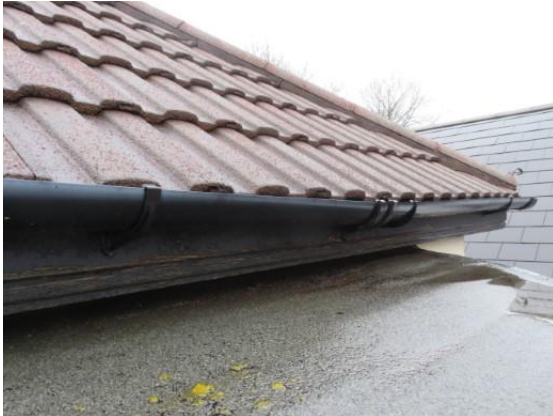
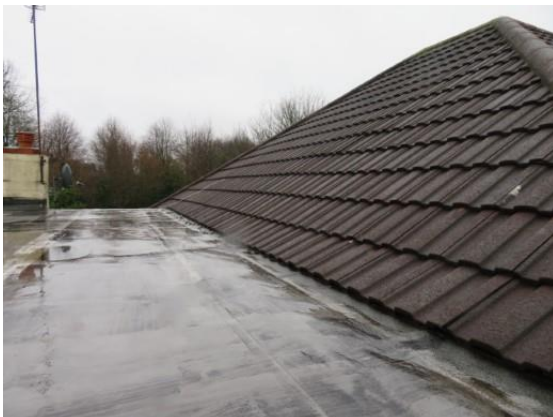
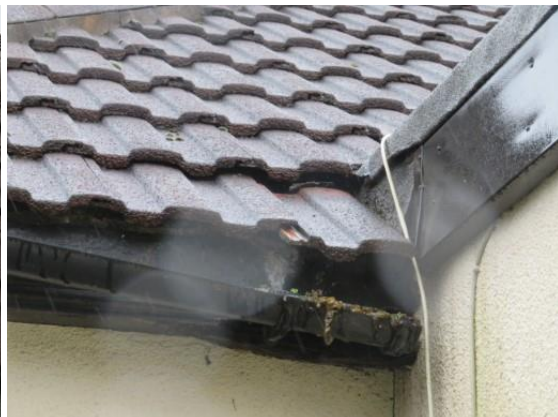
The main roof is hipped and covered with profiled interlocking concrete tiles secured to timber battens. There are half round tiles to the ridge and hips sections. The hip tiles are supported by hip irons. Beneath the roof covering is a secondary waterproof barrier which provides extra protection against water penetration and driving rain.

All tiles seen were in a serviceable condition with no evidence of any major failures or defects. The mortar beneath the hip tiles is complete and intact with no evidence of any major weathering. The top line of ridge tiles is even with no evidence of any undue levels of flexing or bowing.

(Condition Rating 1).

The roof covering has been replaced. You should ask your legal adviser you should ask your legal adviser to check whether the local council has granted building regulation approval for this work. (See also F1 Roof structure).

You should carry out a thorough visual inspection at least once a year, ideally in the Spring to identify and repair any damage that could have been caused by winter weather. Any missing mortar at the verges and beneath any hip or ridge tiles should be replaced. Any moss or other accumulated plant matter should be cleared.

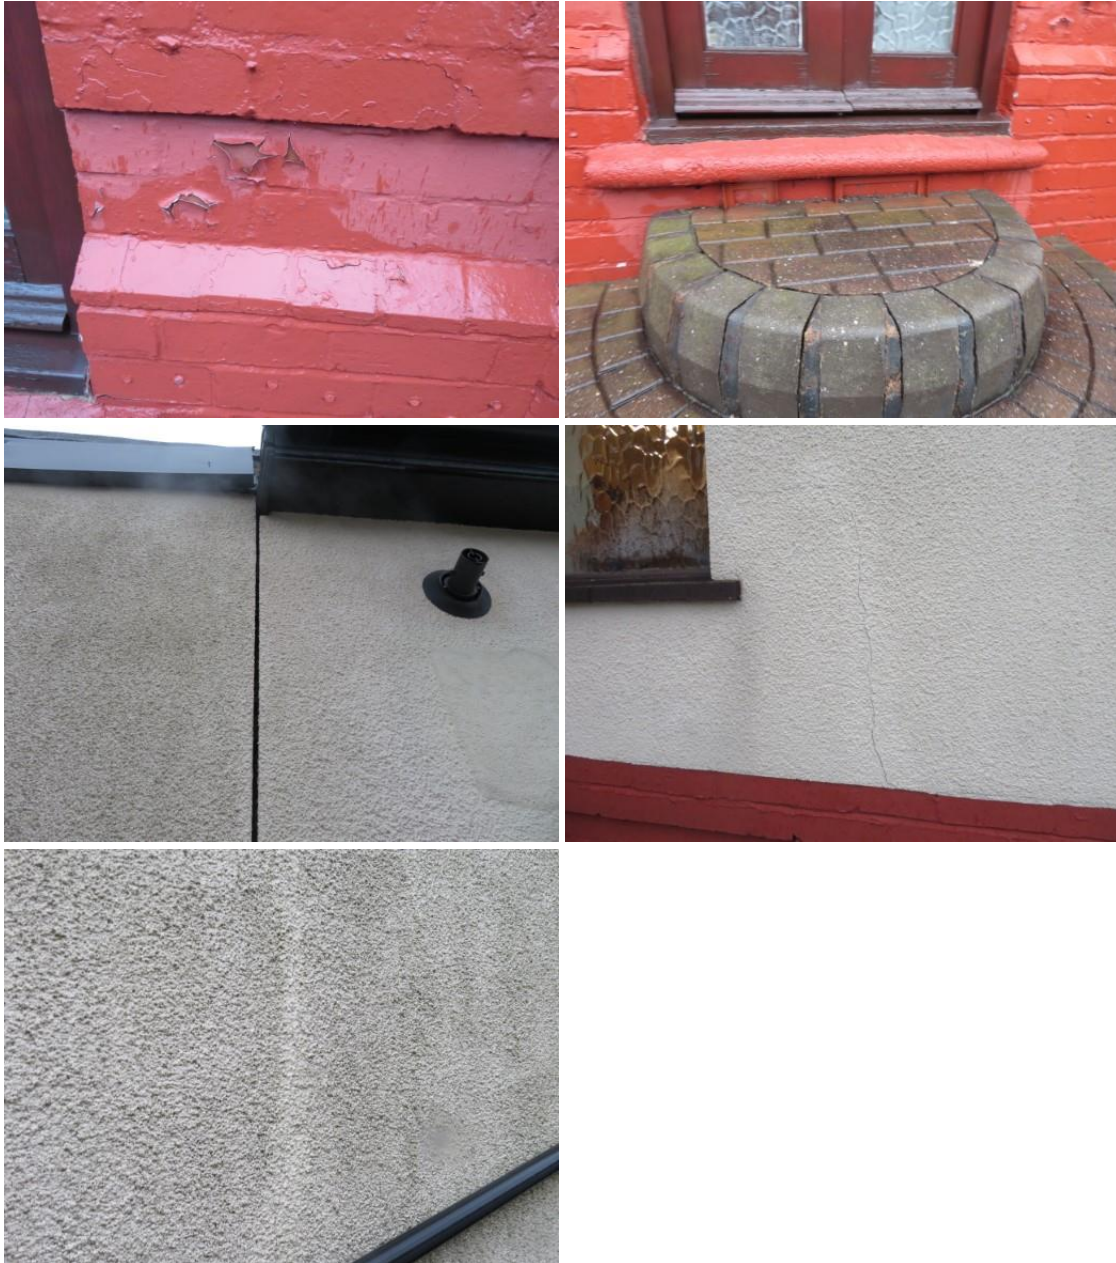
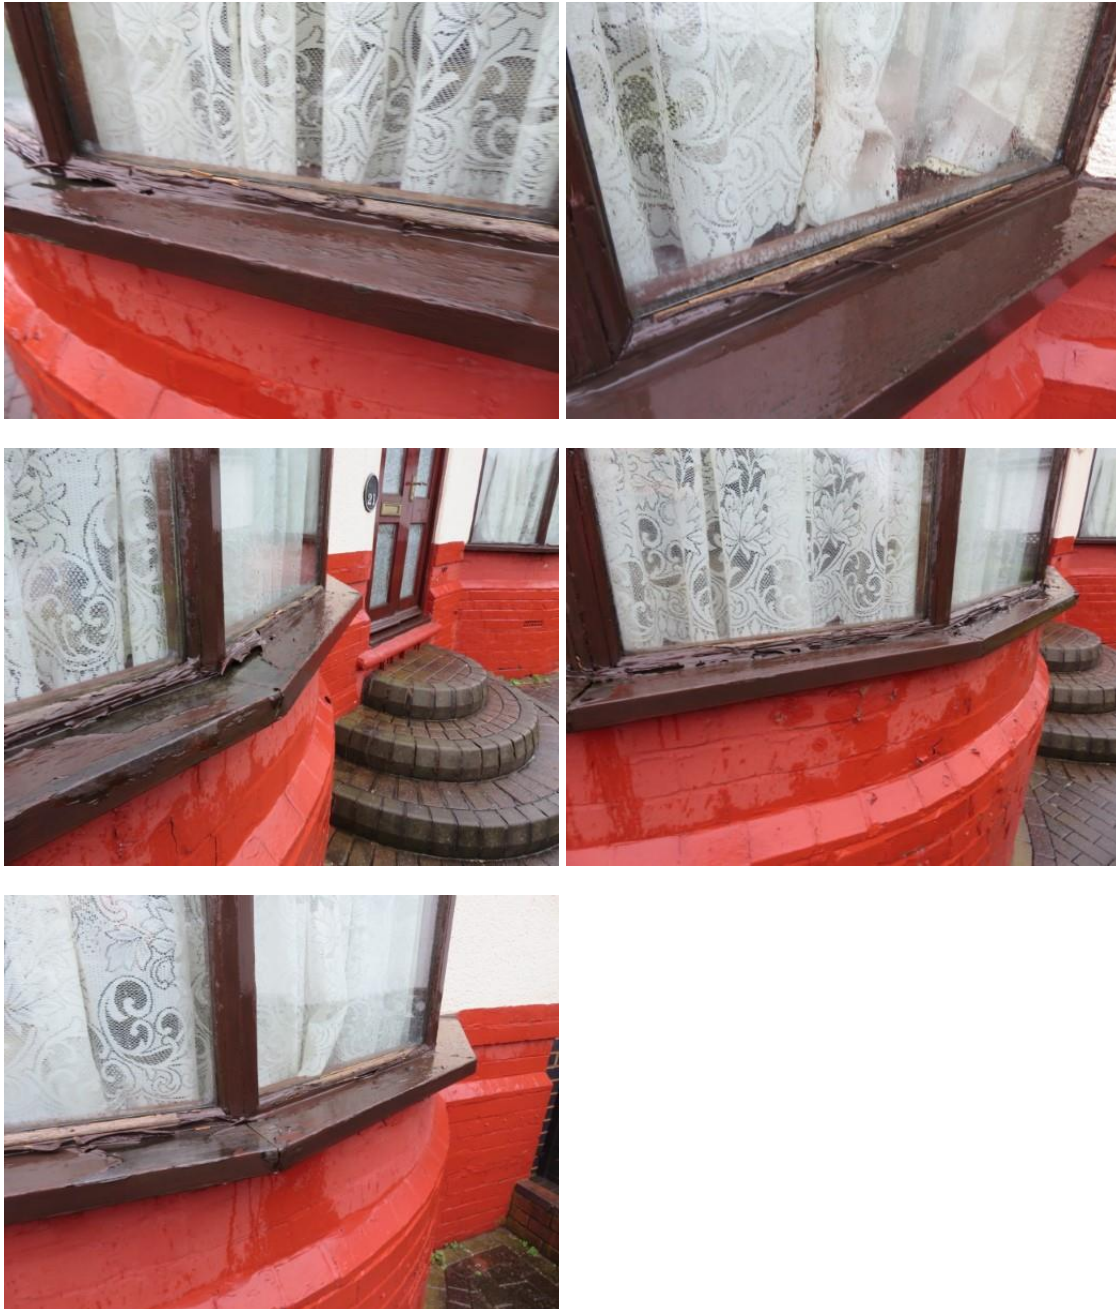
The protective finish and beading sections on the bay windows has deteriorated. There are splits in the sills. The sills are not pitched appropriately for rainwater to run off satisfactorily.

(Condition Rating 3).

The defects noted above are causing dampness to the walls in the bays beneath. You should ask an appropriately qualified person to inspect these windows and advise you. You should consider replacing them with modern PVC equivalent windows to help improve safety, security and thermal performance.

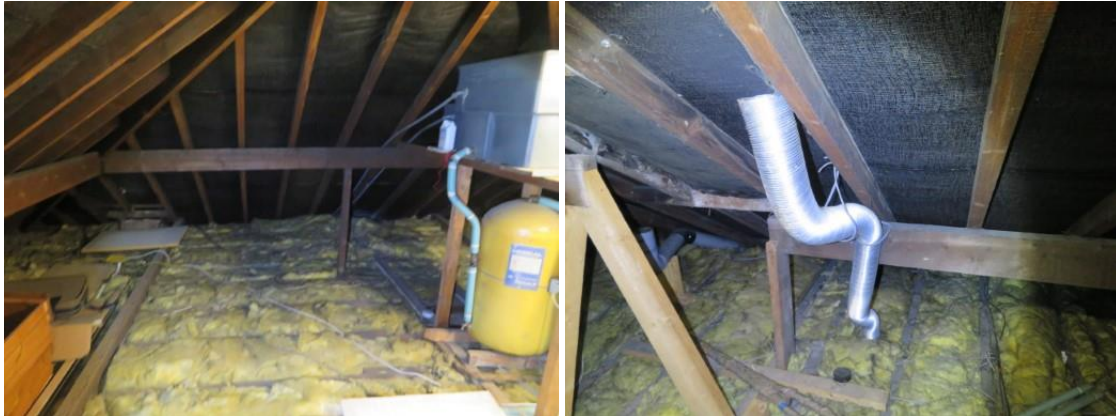
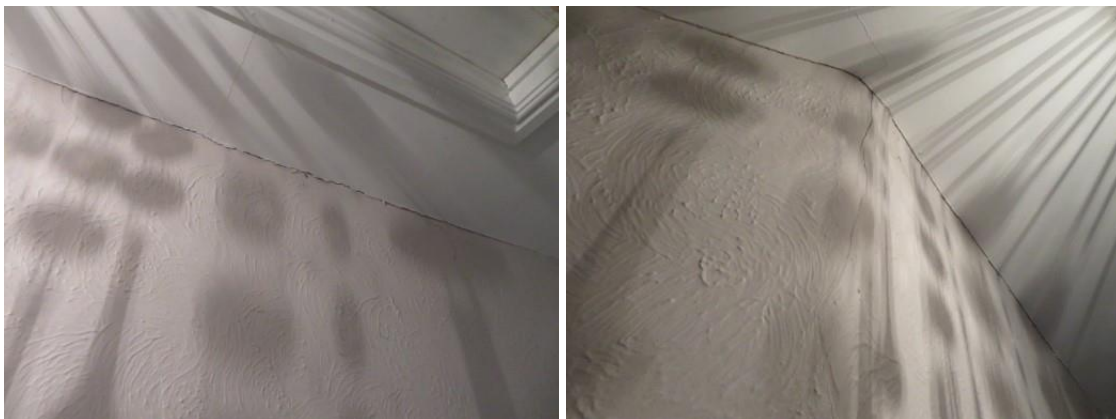
There is some cracking at the junction of the ceiling with the wall in the entrance hall and in the bedrooms. The cracks do not appear recent, as the property has not been redecorated for some time. I expect that you will deal with this when you next redecorate. Due to the age and nature of construction these cracks may re-occur.

(Condition Rating 1).

A textured decorative coating covers the ceiling in the kitchen. This may contain small amounts of asbestos fibres, but only a laboratory test can confirm this. If disturbed, it could be a safety hazard (see section J3 Risks). If the ceiling needs decorating or repairing, you may have to use a contractor experienced in this type of work or an asbestos specialist. In the meantime, the material should not be disturbed, sanded or drilled, without taking suitable safety precautions.

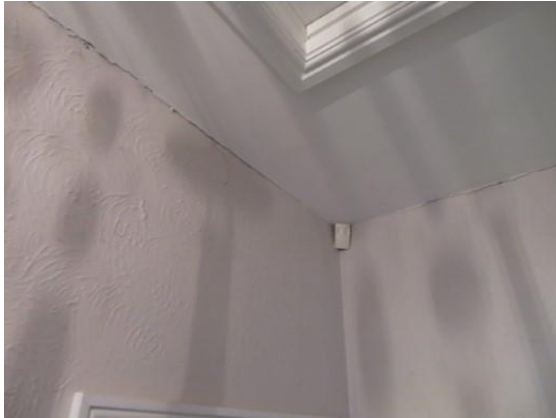
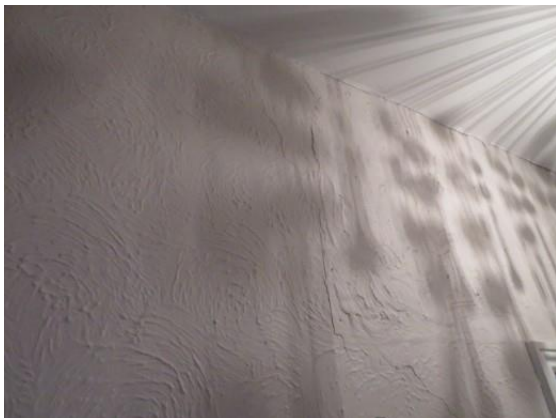
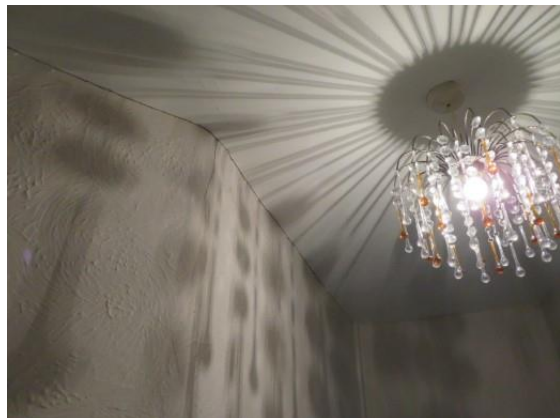
There is some cracking to the textured, plastered wall finish in the entrance hall. The cracks do not appear recent, as the property has not been redecorated for some time. I expect that you will deal with this when you next redecorate. Due to the age and nature of construction these cracks may be likely to re-occur.

(Condition Rating 1).

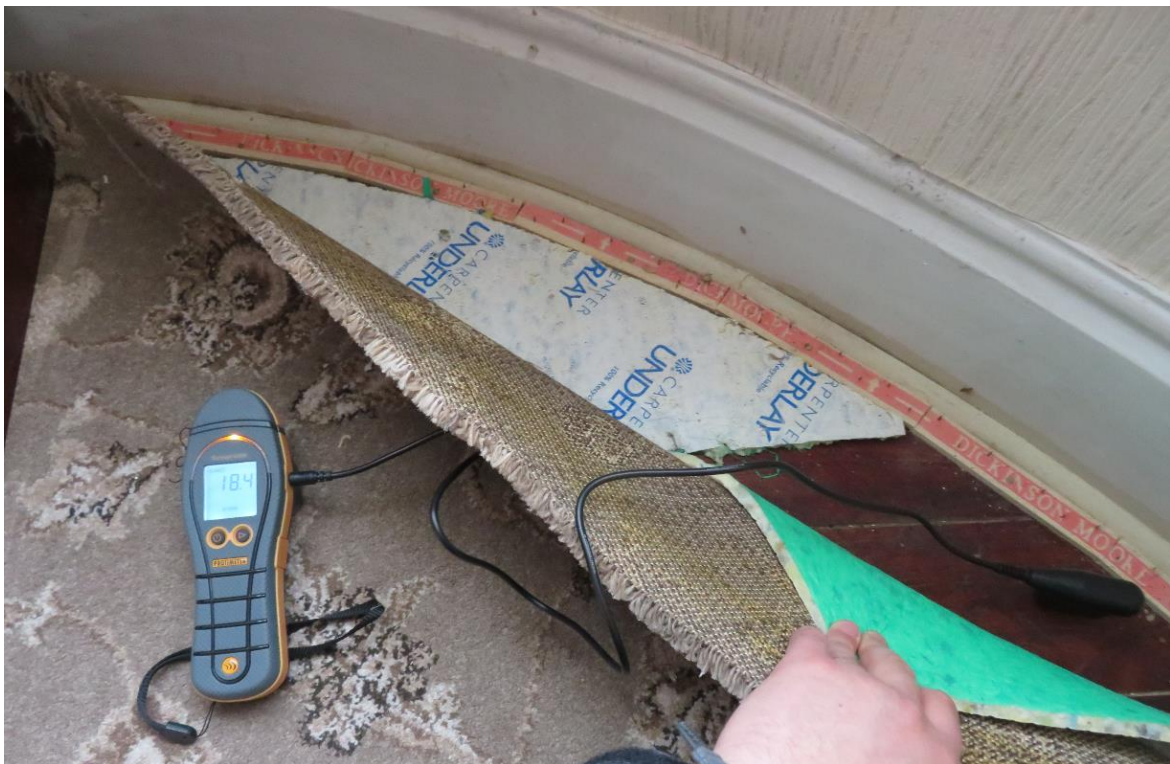
Where walls are damp it is common for this to cause dampness to the adjoining timbers in the subfloor. You should ask an appropriately qualified person to inspect this further. This will be invasive and require the cooperation of the seller. In addition, you should also carry out repairs to prevent dampness to the bays and subsequent timbers.

(Wood moisture equivalent to floor board in left-hand bay above 18% action level).

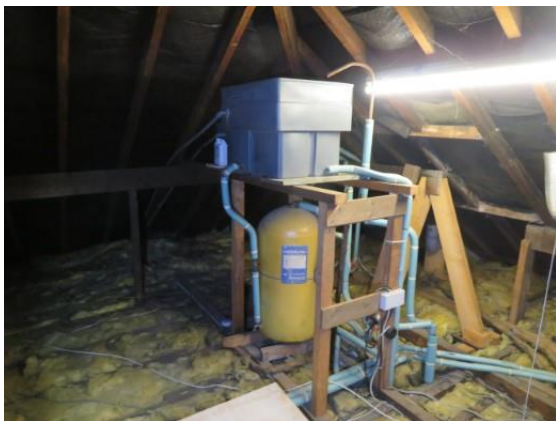
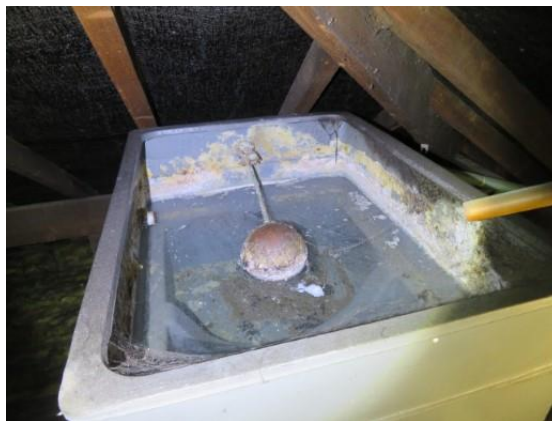
There is no protective lid on the cold-water tank causing sediment / debris to enter the tank. This is a safety hazard. (See section J3). I understand that you are upgrading the system and will be removing these tanks.

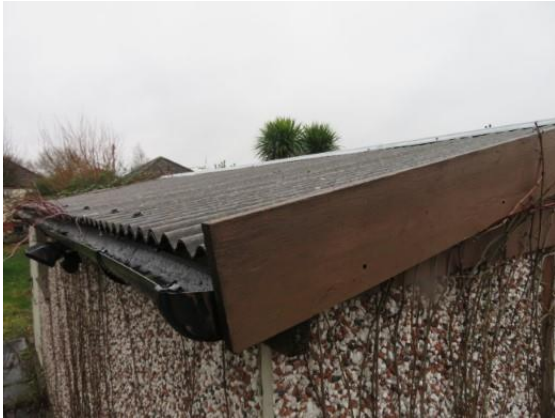
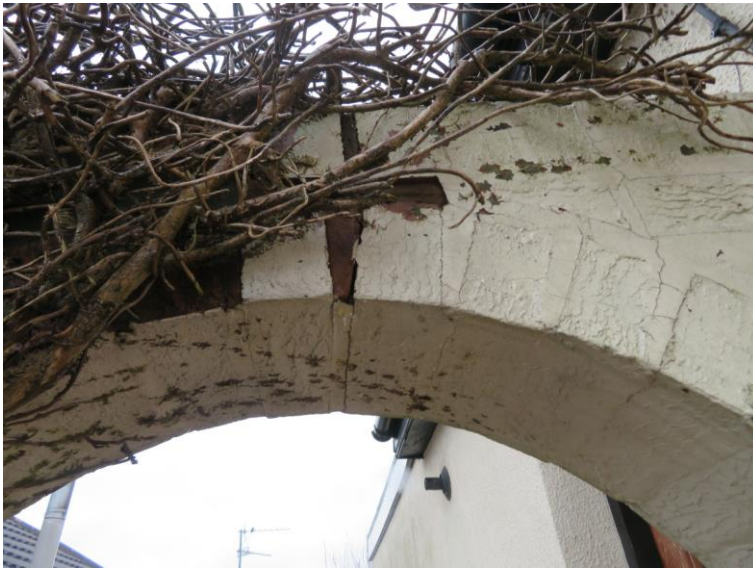
There is a brick arch on the left-hand side. There is cracking to the mortar joints. Near by vegetation is growing over the arch affecting the brickwork. If the arch becomes unstable, this could be a safety hazard. (See section J3).

You should ask an appropriately qualified person to remove the vegetation, inspect the arch and carry out repairs.
