Clients Brief

We have been asked to assess whether a wall can be removed at ground floor level within the rear left hand corner of the property and comment on a distortion on a doorway at first floor level to the rear left hand bedroom.

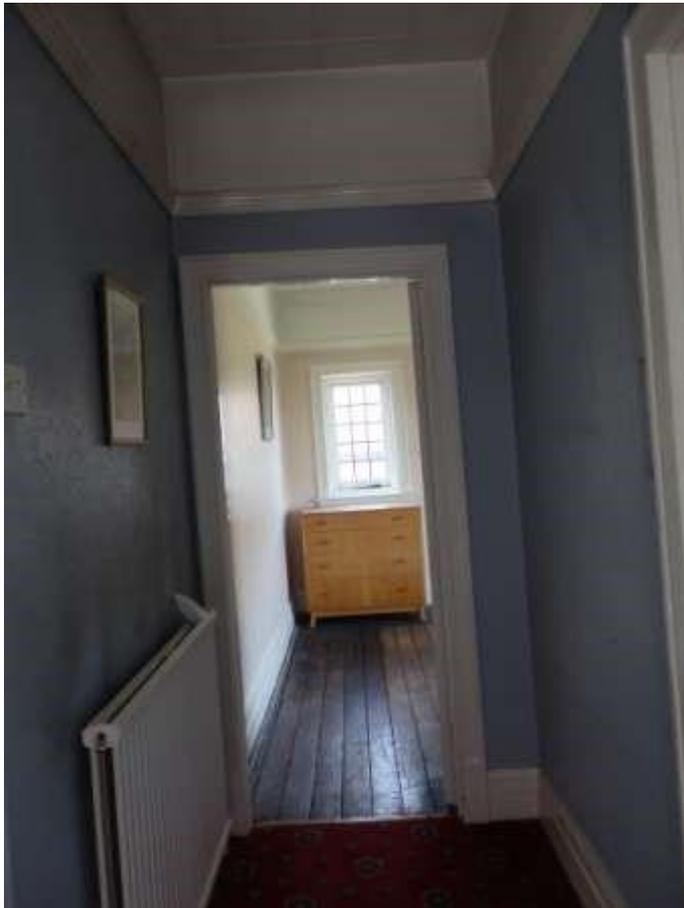
At first floor level the distortion on the doorway into the rear left hand bedroom, which we estimate is a dip of approximately 50mm over the length of the door, the wall is a heavy masonry wall and simply built off floor joists with no supporting wall underneath

The dip runs to the right - photo is not straight!

The distortion on the doorframe, which dips downwards towards the rear, is due to the wall being simply built off the floor joists.

The distortion on the doorframe at first floor is typical of the age of property with a heavy masonry wall built directly off floor joists which would have been common for that age of property.

We would therefore advise that a beam is installed directly beneath this wall, having first jacked the wall back into position so as to level the doorframe and the floor.

Unfortunately this does not comply with current regulations and we would advise that a beam is installed within the ceiling of the lounge area below the wall.

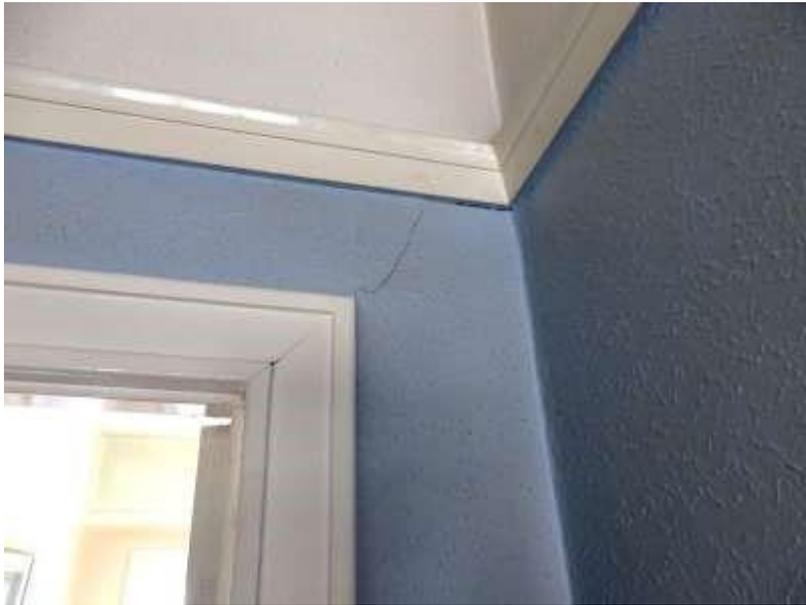
Minor cracking was also evident around the door head owing that the movement was on going.

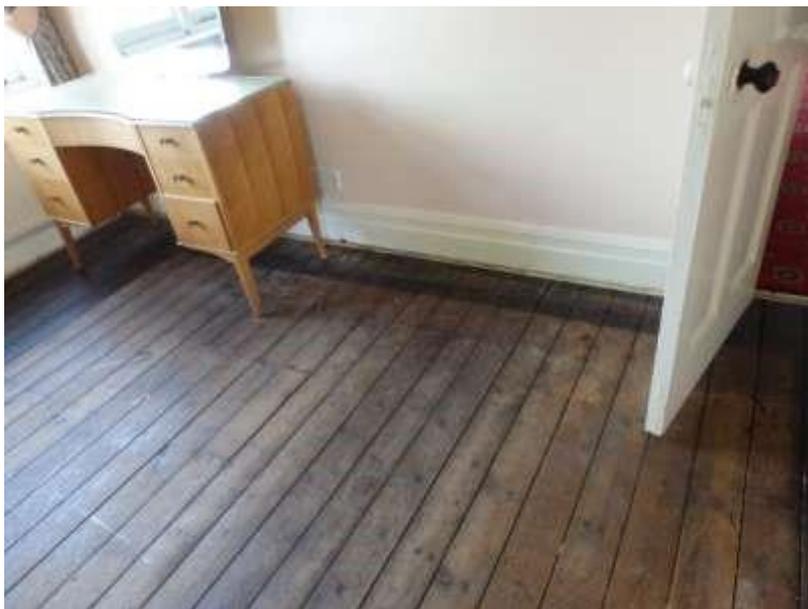
A distortion is also showing on the floor in the rear bedroom which is dished against the wall.

There was no carpet in the rear left hand bedroom showing that the floor joists run from front to rear.

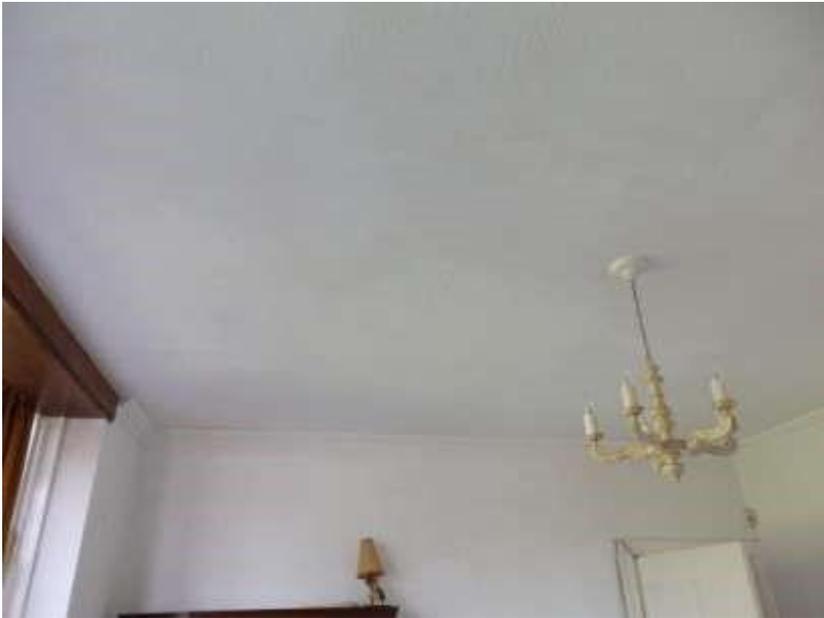
In the lounge area a distortion can be seen on the ceiling below the wall. Never noticed this myself - the unsupported wall above runs parallel to the wall the photo is facing midway between the wall and light fitting. The beam would therefore run from a wall to the right and to the bay window just visible to the left. Padstone in the wall is obvious - how to support the beam over the bay? Is there a beam spanning the bay already? Is it strong enough to take the additional weight?

The wall separating the dining room and lounge does not line up with the wall at first floor level. This is the wall facing us in the photo above

We therefore consider that this wall can be removed, however at first floor level there is a masonry wall separating the bathroom and the bedroom. Already mentioned the position of this - midway between the wall facing us in the photo above and the light fitting

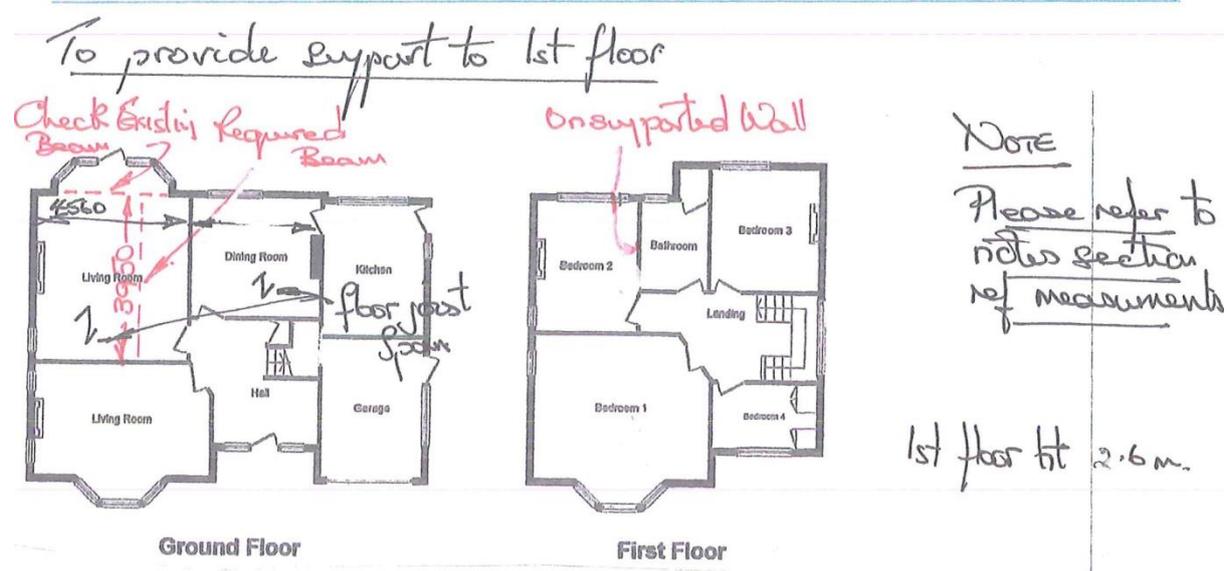
The wall between the breakfast room and the kitchen does not support either the wall at first floor or floor joists, consequently it can be removed without further support at first floor as long as support is installed for the masonry wall separating the bathroom and bedroom as stated. **So wall can be removed as it supports nothing.... as long as the wall above receives the beam???**

Above drawing not to scale - from estate agents plan the kitchen and garage on ground floor are single storey. It is the bedroom 2/bathroom wall that is the offending wall in question. That lines up with the SE's red dashed beam location. What beam is likely to be in the bay window he annotates as "check existing beam"?
