# BUILDING SURVEY REPORT

SURVEY DATE 13 Jan 2020

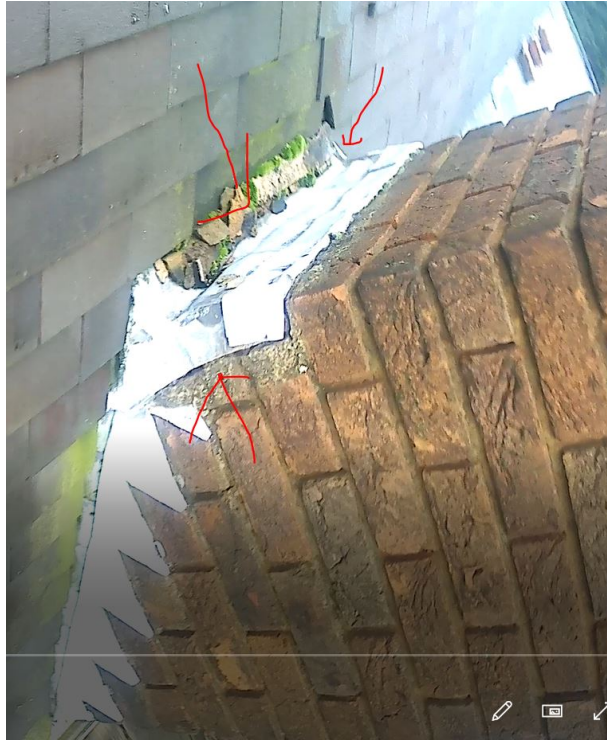
4.1 Chimney Stacks	Condition rating	3
<b>Construction &amp; Type</b>	<p>There are two chimney stacks associated with the property which are brick built with lead flashings at their base.</p> <p>The right hand chimney which is uncapped supports a gas fire in the lounge. The rear chimney has a flue with rain cowl supporting the boiler and an uncapped pot for the open fire in the dining room.</p>		
<b>Nature of inspection and Limitations</b>	<p>The chimney stacks were examined from ground level with the aid of binoculars, and a camera on an extended pole, for possible defects including undue movement, distortion, chemical or weather related damage, brickwork, render and pointing damage and other evidence of failure.</p>		
<b>Condition</b>	<p>The flashings at the base of the right hand stack have lifted and staining to the lounge ceiling below suggest rain is entering the property.</p> <p>Both chimneys require repairs to the pointing which has worn away.</p> <p>The pots are uncapped and open to the elements. If any pots are left uncapped then rain can penetrate the flues and damp can appear inside the property on the breasts. Providing fireplaces are regularly used then any penetrating moisture will dry out, however if fireplaces are used infrequently then it would be prudent to provide rain cowls to allow flue gases to escape but prevent moisture ingress to the flue.</p>

chimney flashings need attention

<b>Action Required</b>	<p>Flashings need re-dressing or renewal, brickwork needs re-pointing and the flaunching to the rear chimney needs clearing of vegetation prior to checking.</p> <p>Capping of the open pots is required to prevent water penetration to the flues</p>

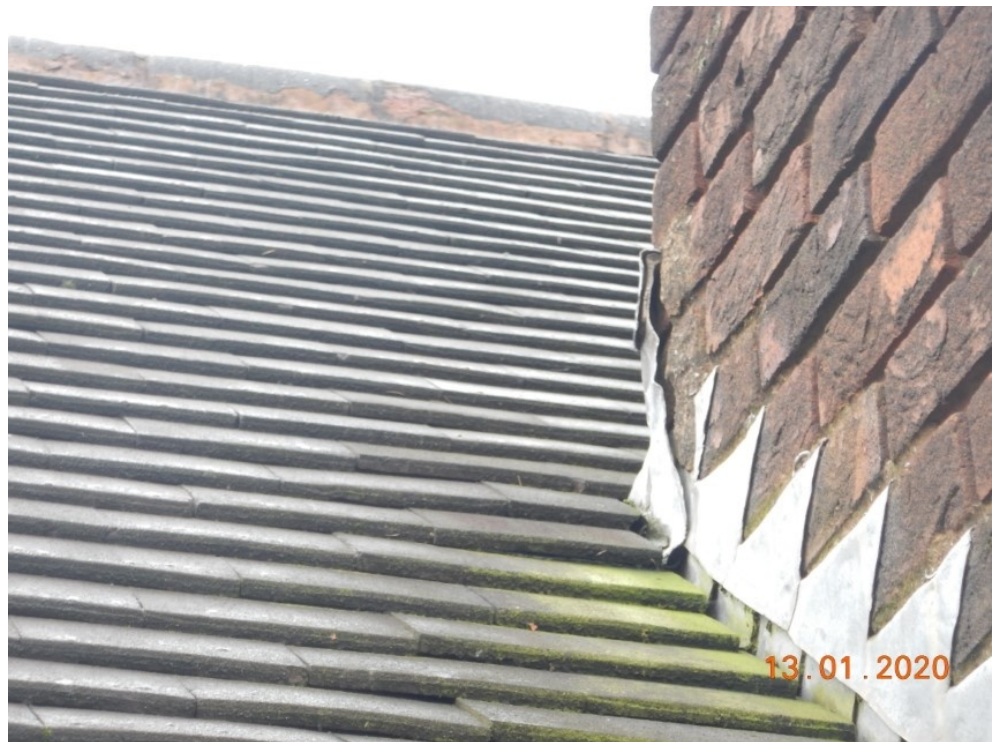
flashings lifting

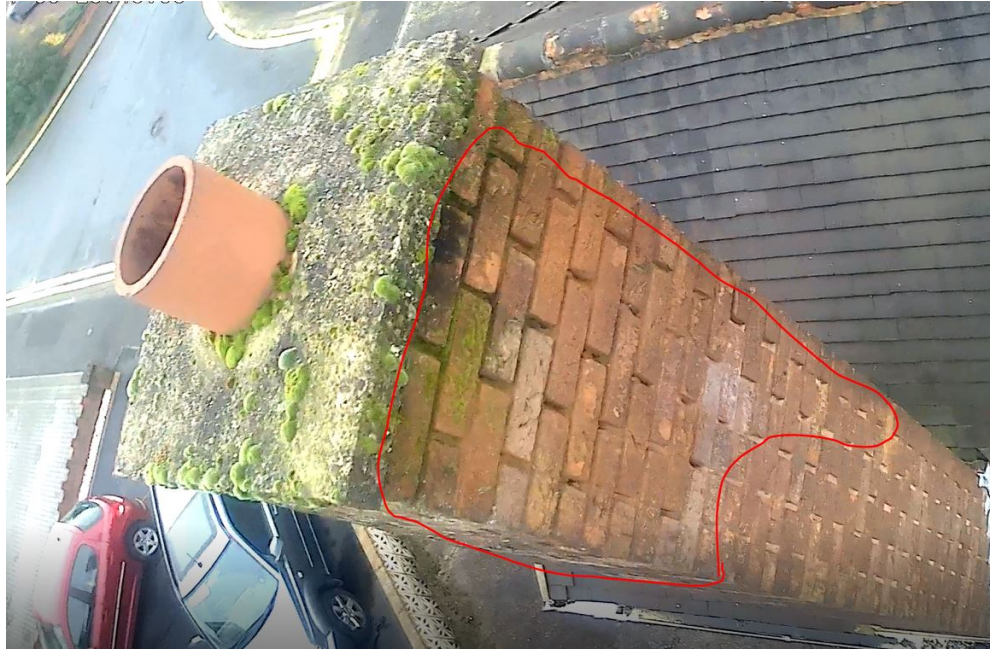
pointing missing

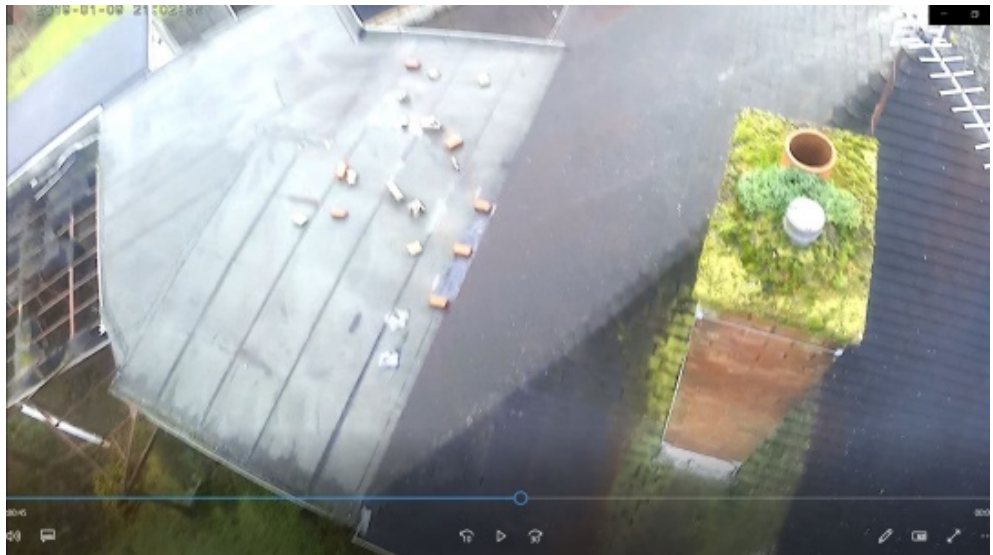
rear chimney flaunching in poor condition

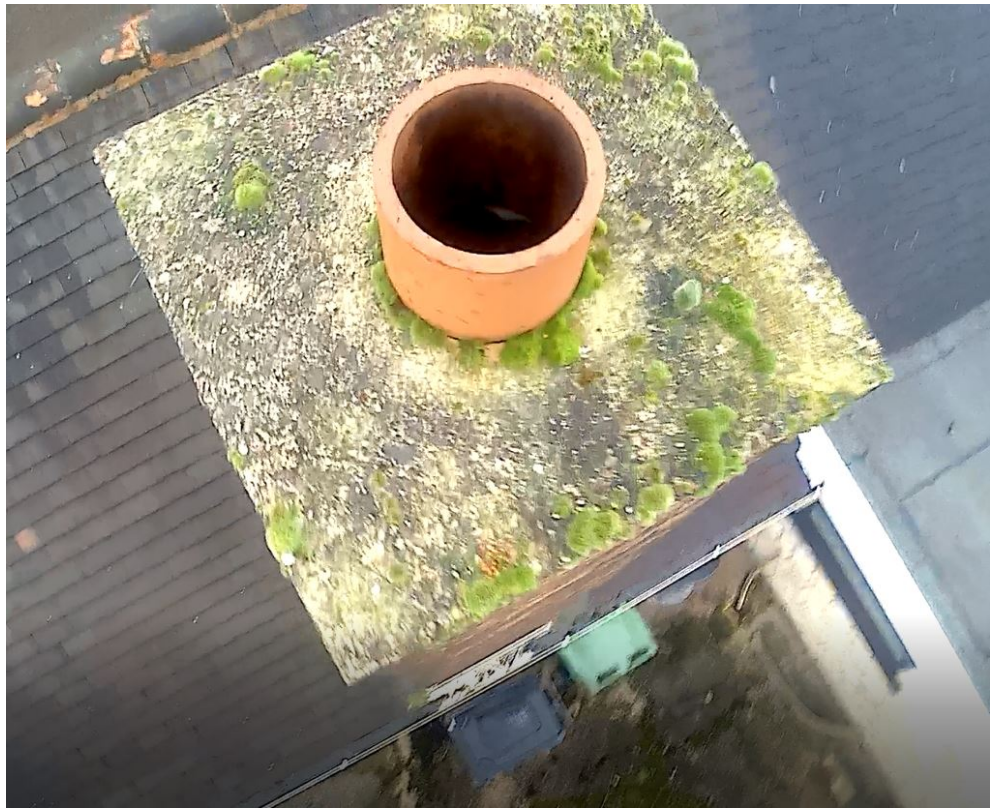
right hand chiney uncapped

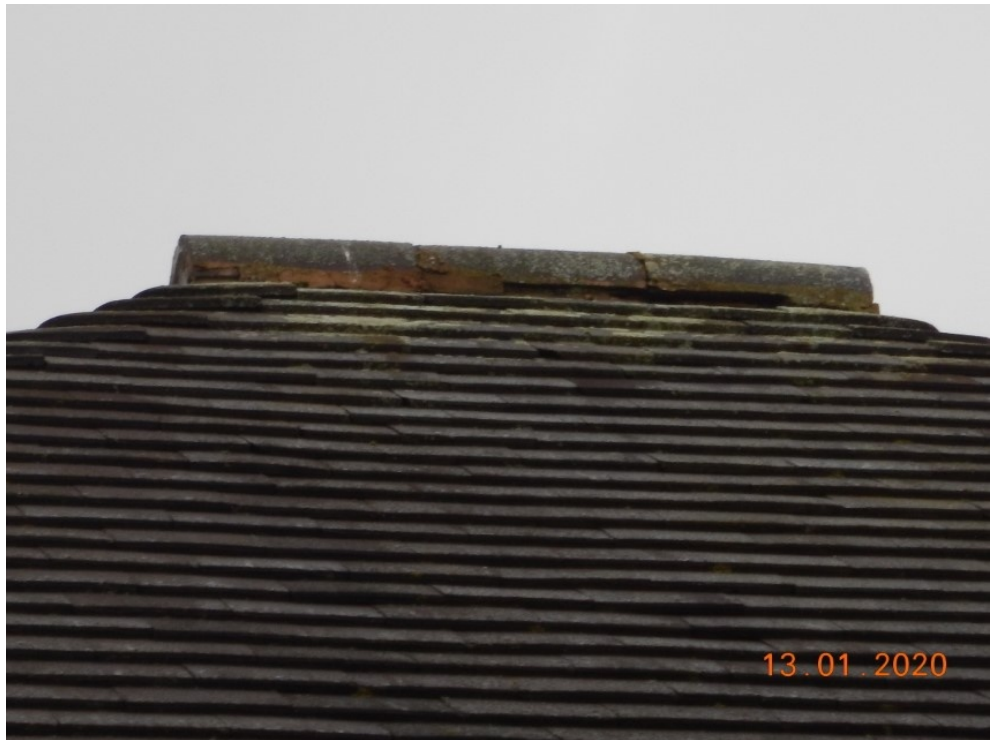
<b>Condition</b>	<p><b>Pitched Sections</b> The ridge tile pointing is failing and some repairs have been poorly completed.</p> <p>There are a small number of slipped, chipped and cracked tiles visible on the main roof pitches. The number of damaged tiles is within a normal range for a roof of this type and age and would not significantly affect the performance of the roof at this stage.</p> <p><b>Side Flat Sections</b> The flat roof is not in a serviceable condition, there's no solar chippings, the felt is lifting, the felt is breaking down in places, there are signs of patching and sealant and the underside is soaked.</p> <p><b>Porch Flat Sections</b> The flat roof is not in a serviceable condition as the felt is breaking down.</p> <p>Compared to traditional coverings such as tiles and slates, most bitumen felt roofs have a typical life of 10-25 years. They are also prone to sudden failure and leakage. Periodic re-covering will therefore be necessary. When this is undertaken, the supporting structure may also need some attention. It is estimated that the roof is at the end of it's expected service life.</p>

ridge tiles need re-bedding

<b>Action Required</b>	<p><b>Pitched Sections:</b> All ridge tiles need lifting and re-bedding (not re-ponting!).</p> <p>Any slipped, missing or broken tiles on the roof pitches should be repaired and replaced. You should carry out a thorough visual inspection at least once a year, ideally in the Spring to identify and repair any damage that could have been caused by winter weather. Any missing mortar at the verges and beneath any hip or ridge tiles should be replaced. Any moss or other accumulated plant matter should be cleared</p> <p><b>Flat Sections:</b> Both flat roofs need stripping, the roof boards checking and replacing as required prior to re-covering.</p>

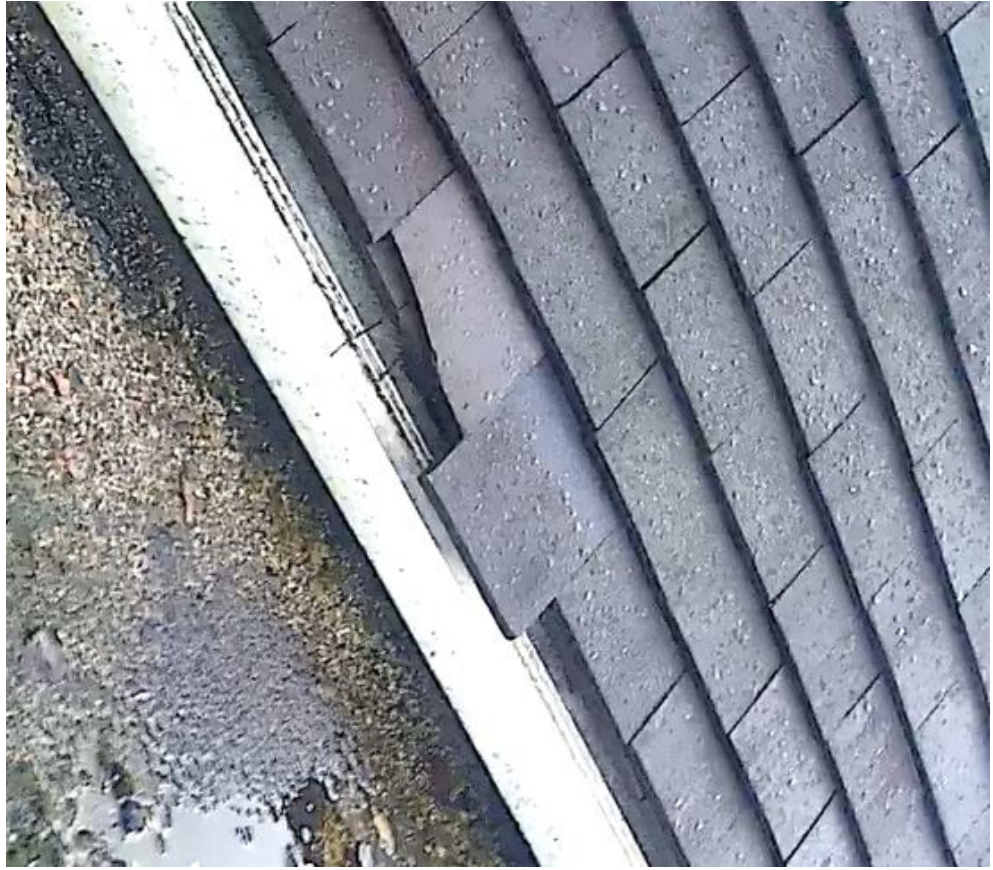
slipped tiles

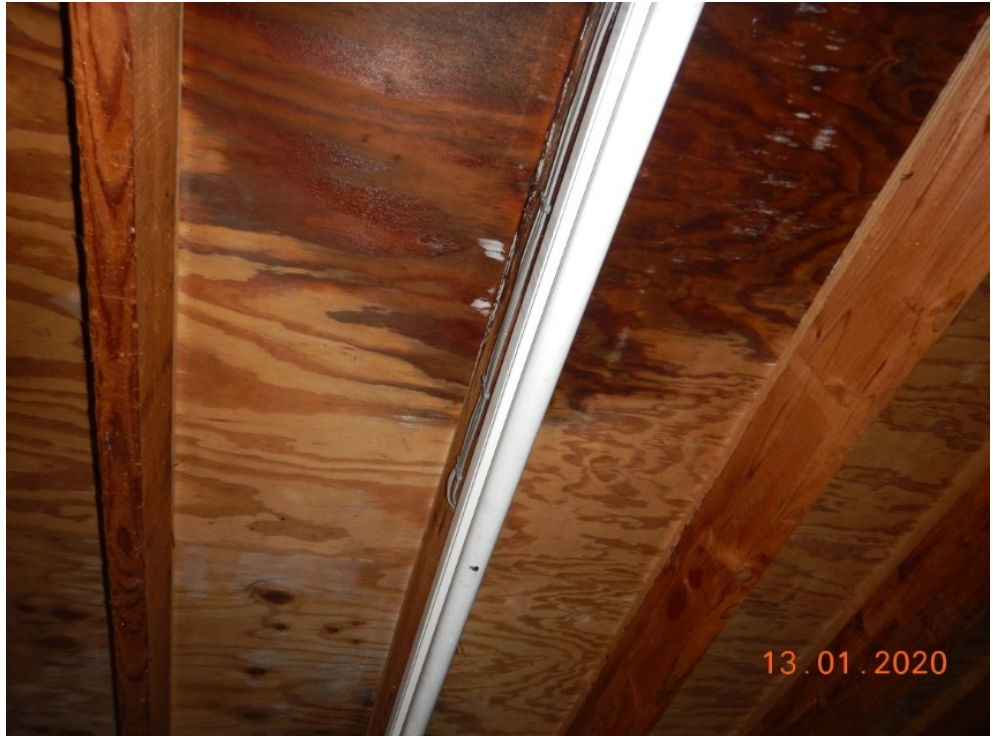
roofboards soaked

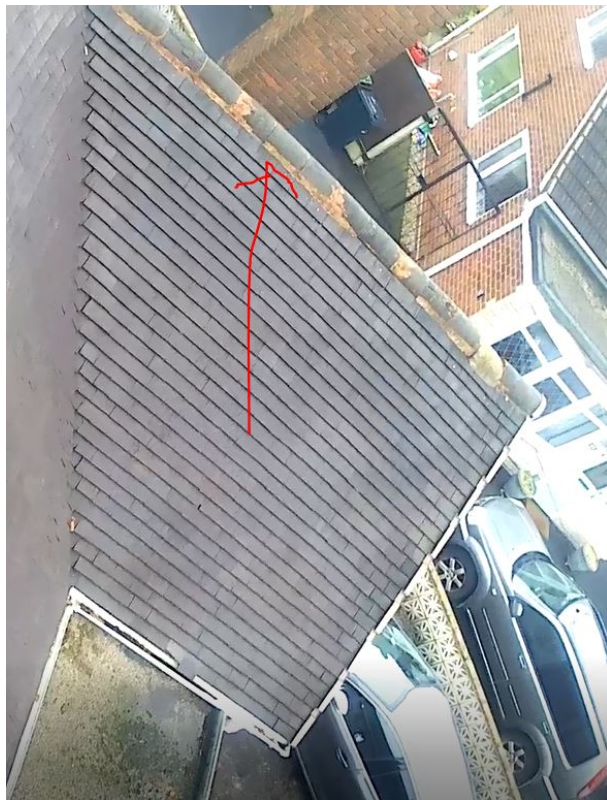
ridge tiles need renewal

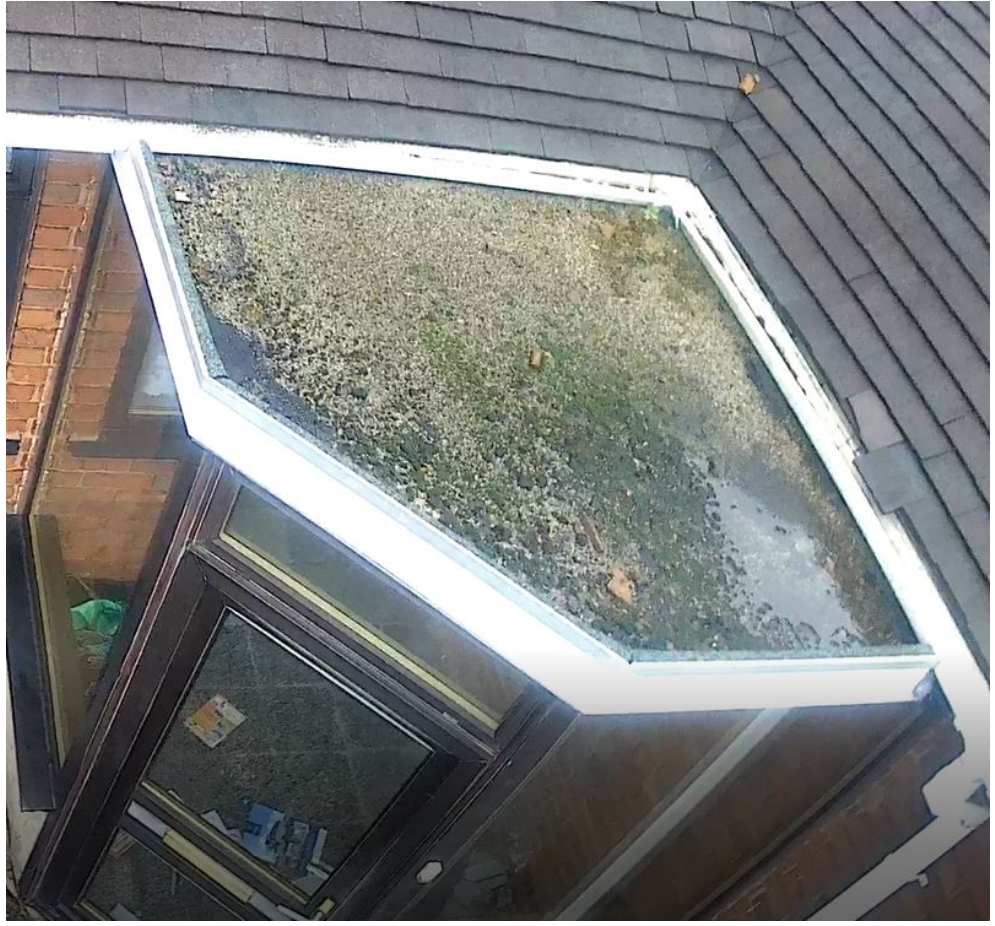
porch roof needs renewal

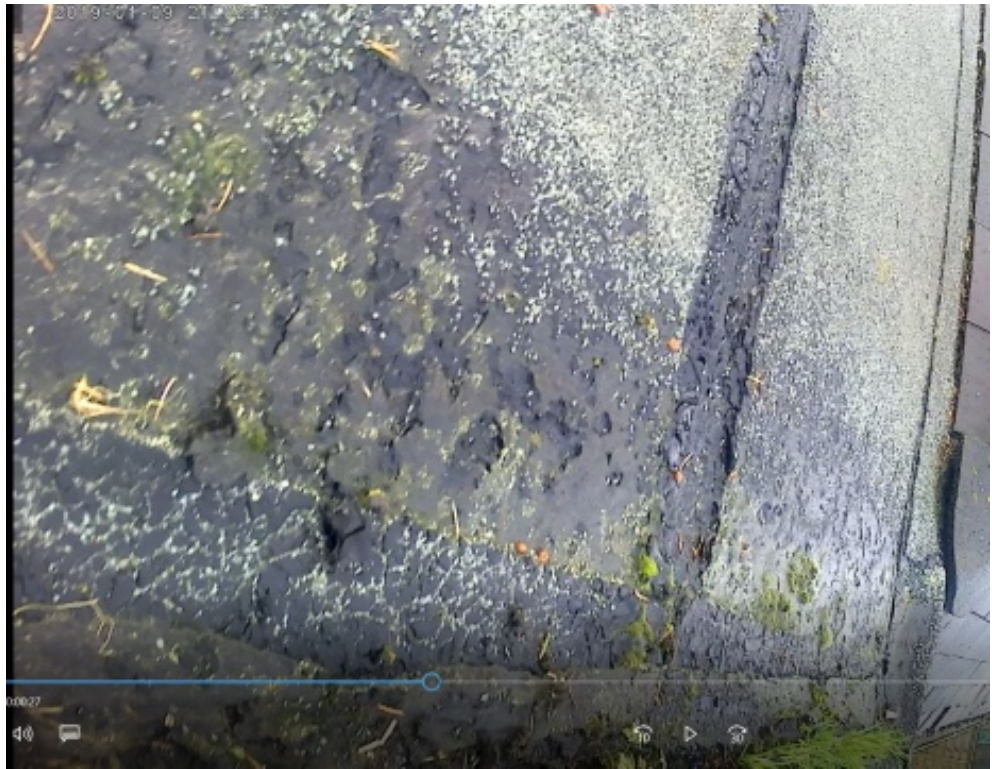
felt damage

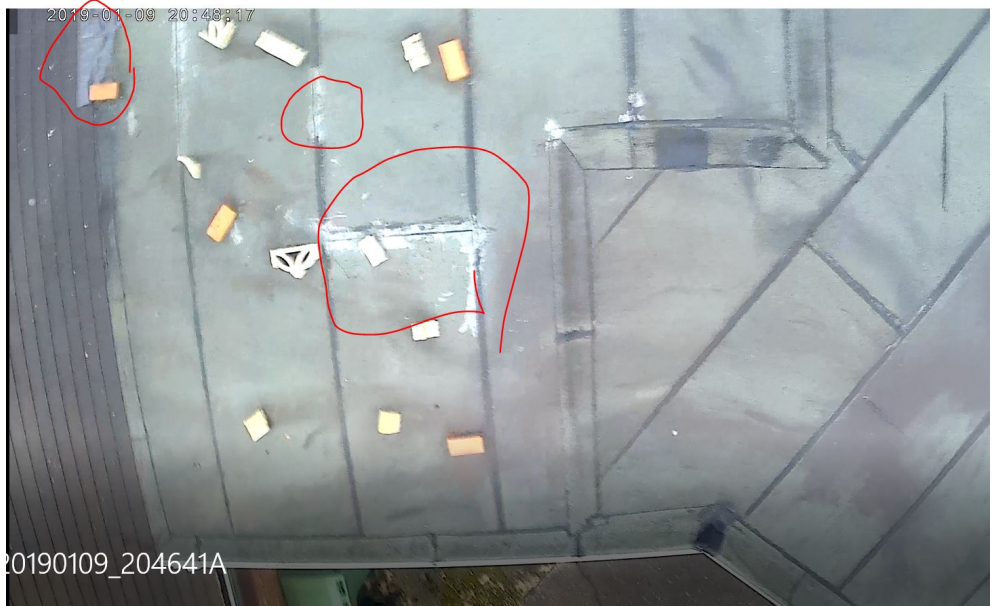
flat roof poor repairs

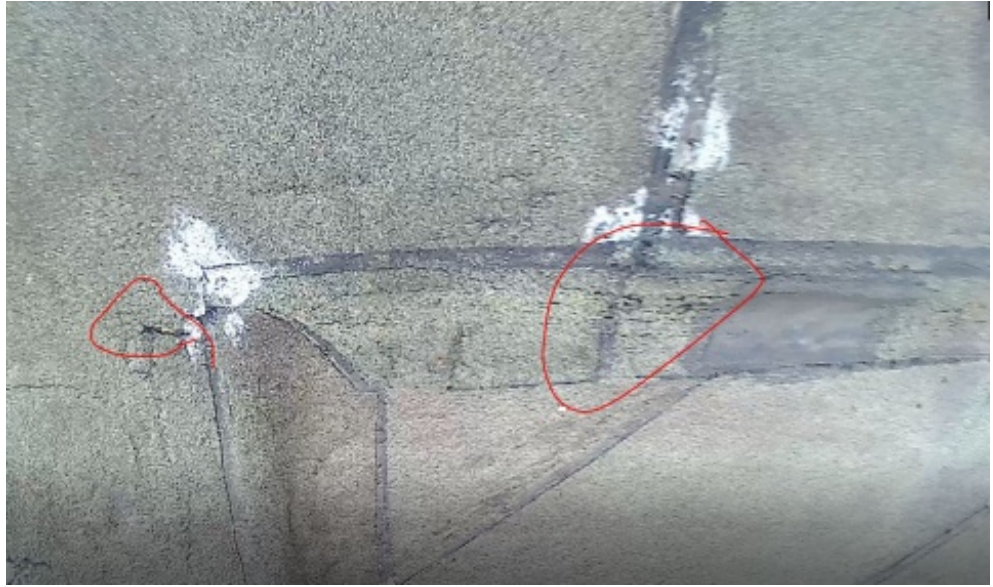
felt breaking down

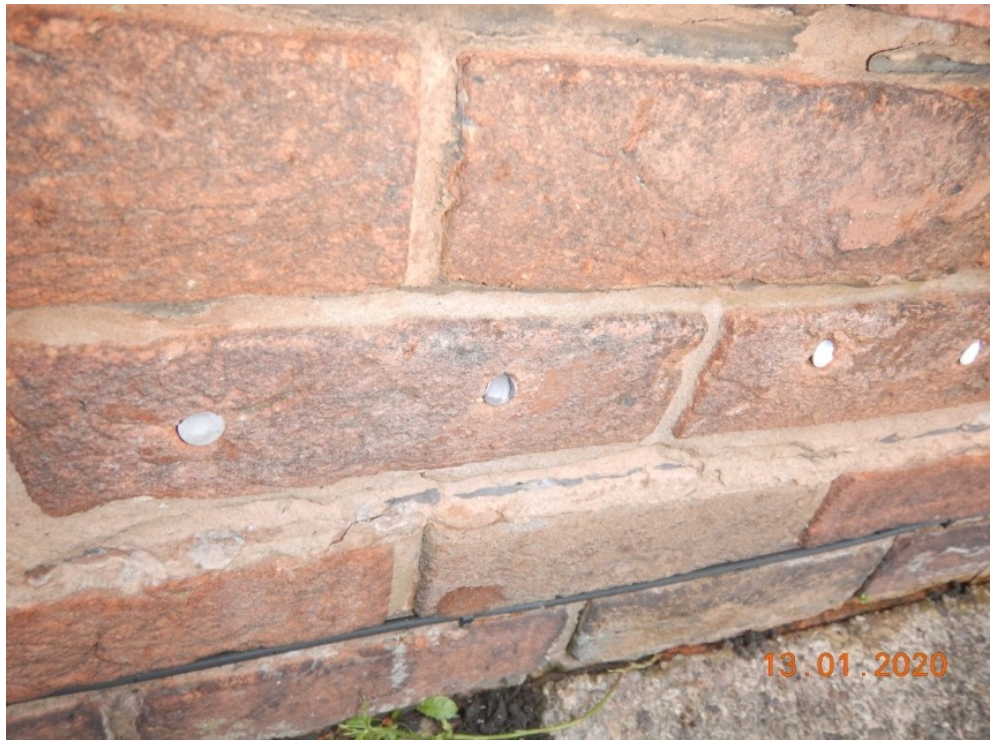
<b>Condition</b>	<p><b>Foundations / Movement</b></p> <p>During a non-invasive inspection of this type it is not possible to expose the foundations. A property of this type and age would not be expected to have foundations that meet current standards, but this should not be considered to be unusual. No evidence was seen of cracking, or other damage, which might indicate that the foundations are failing to provide adequate support for the property.</p> <p><b>Other Aspects</b></p> <p>In most external walls there should be a damp proof course (DPC) just above ground level. This is an impervious layer present to prevent dampness rising up the walls from the ground. In modern properties this is often a plastic membrane but in older properties other materials such as bitumen felt or slate are often found. Houses built before 1880, or so, usually have no provision to prevent dampness rising up, or penetrating through, the walls.</p> <p>In this case the bitumen DPC can be seen at the base of the walls and above a retro fitted chemical damp course has been installed suggesting the original damp course has failed.</p> <p>There is no evidence that the wall cavities have been filled with insulation (cavity wall insulation) and it is unlikely that they would have been filled at the time of construction. The energy efficiency of the property may be improved by installing insulation, however not all properties are suitable for having cavities filled and a survey by a specialist company should be conducted prior to any installation.</p> <p>No significant defects were noted during my inspection and the external walls were found to be structurally sound.</p>

conventional DPM and retro chemical injection

<b>Action Required</b>	<p>A full damp survey and remedial works is required.</p>

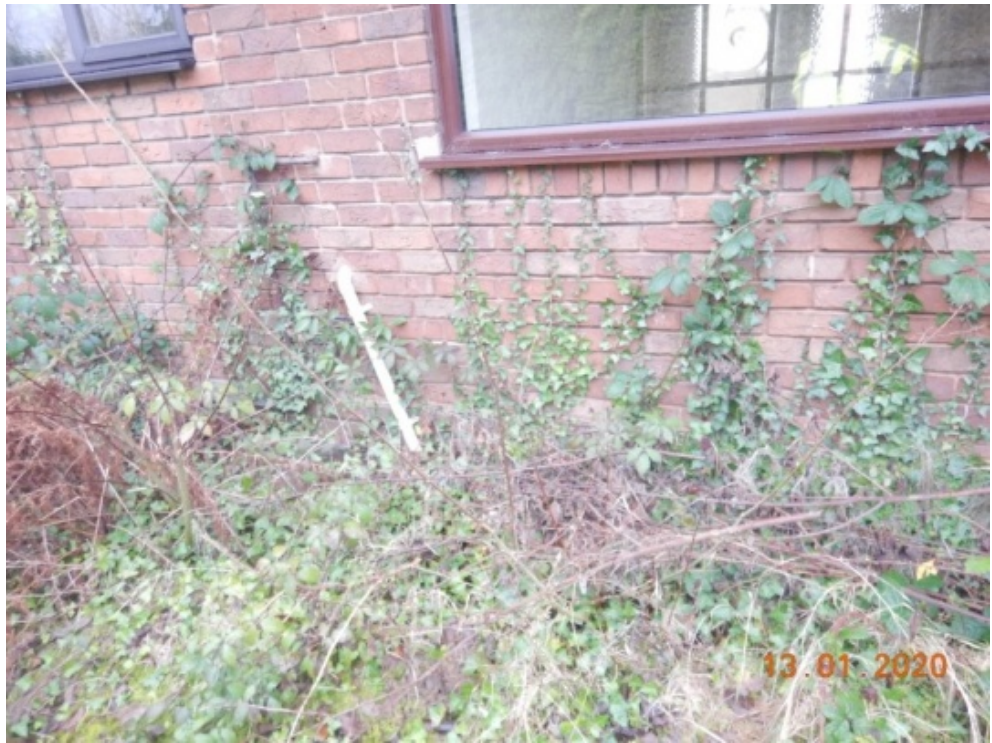
ivy to front and side walls

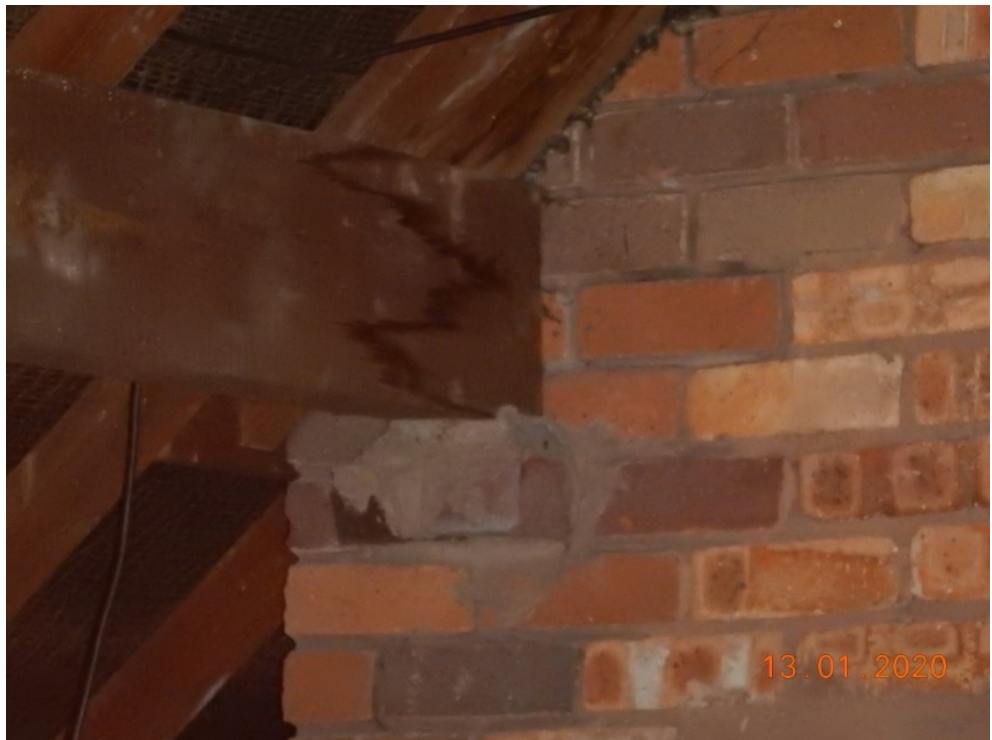
Staining to timber around chimney

<b>Action Required</b>	<p>Regularly monitor timbers, at least twice a year, for evidence of wood boring insects and other such infestations.</p>

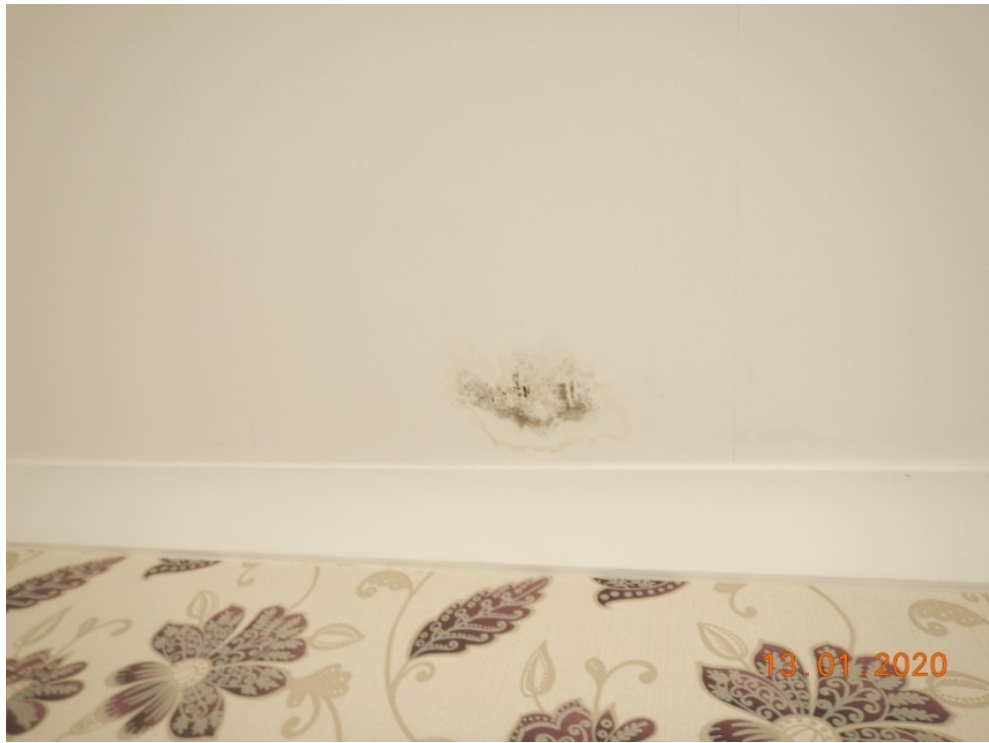
This is below the chimney stack in reception room 1 (right of front door)

mould due to rain ingress from right hand chimney

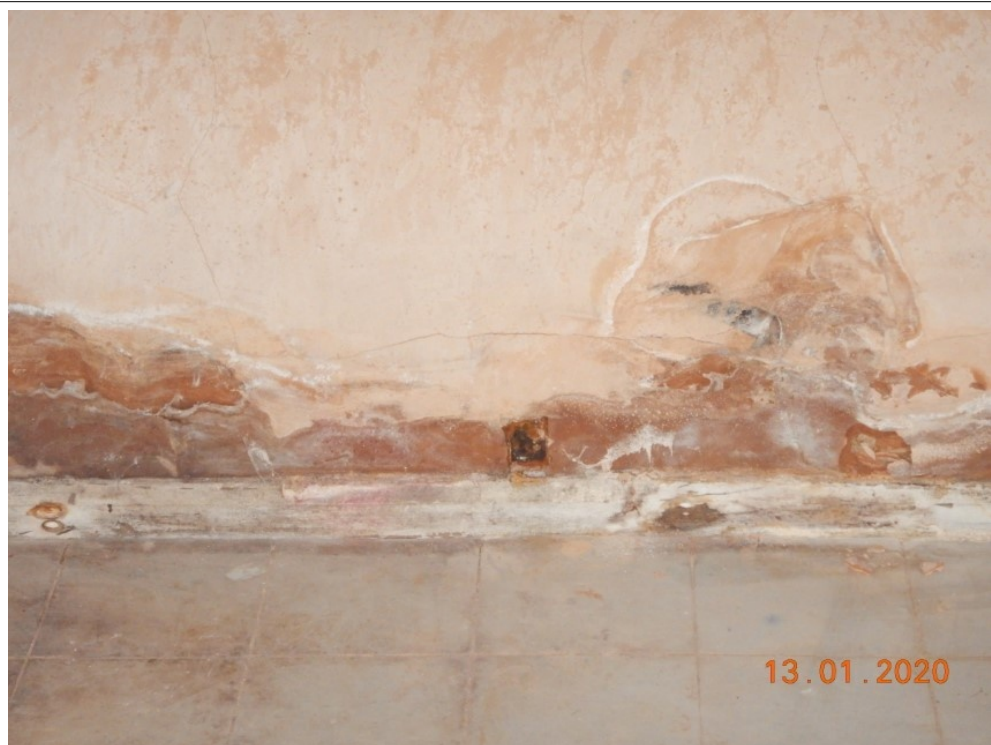
The is the internal wall between  
bedroom one (front) and bedroom two  
(rear)  
To the left is the external wall

5.3 Walls	Condition rating	3
<b>Construction &amp; Type</b>	Internal walls are primarily of solid masonry construction.		
<b>Nature of inspection and Limitations</b>	<p>Internal walls were examined for indications of bowing, leaning, cracking and undue surface failure/damage. Moisture meter readings were taken at regular intervals where access and wall construction/location permitted.</p> <p>Moisture meter readings can only provide a guide as to the presence of dampness and the recording of high readings can be affected by other factors, for example metallised wall finishes, chemical salts within internal plaster, or reactive materials below the plaster surface. A definitive and complete diagnosis for the presence of dampness, and the cause, will involve further testing requiring invasive methods that will cause some damage to the wall surfaces.</p>		
<b>Condition</b>	<p><b>Original structure</b></p> <p>The walls are showing the highest possible moisture reading to most areas and the plaster is breaking down consistent with rising damp. In line with the external observations its clear the damp is a long-term issue that has not been resolved.</p> <p><b>Extension</b></p> <p>No significant defects were noted during my inspection and the internal walls were found to be structurally sound. No evidence was seen of any cracking which might indicate that the property is subject to subsidence or unusual settlement. All moisture meter readings recorded around the property were found to be within a normal range indicating that, in those areas that could be accessed, it is not affected by rising or penetrating damp.</p>

rising damp

<b>Action Required</b>	Large areas of wall plaster need hacking-off prior to treatment and reinstatement.

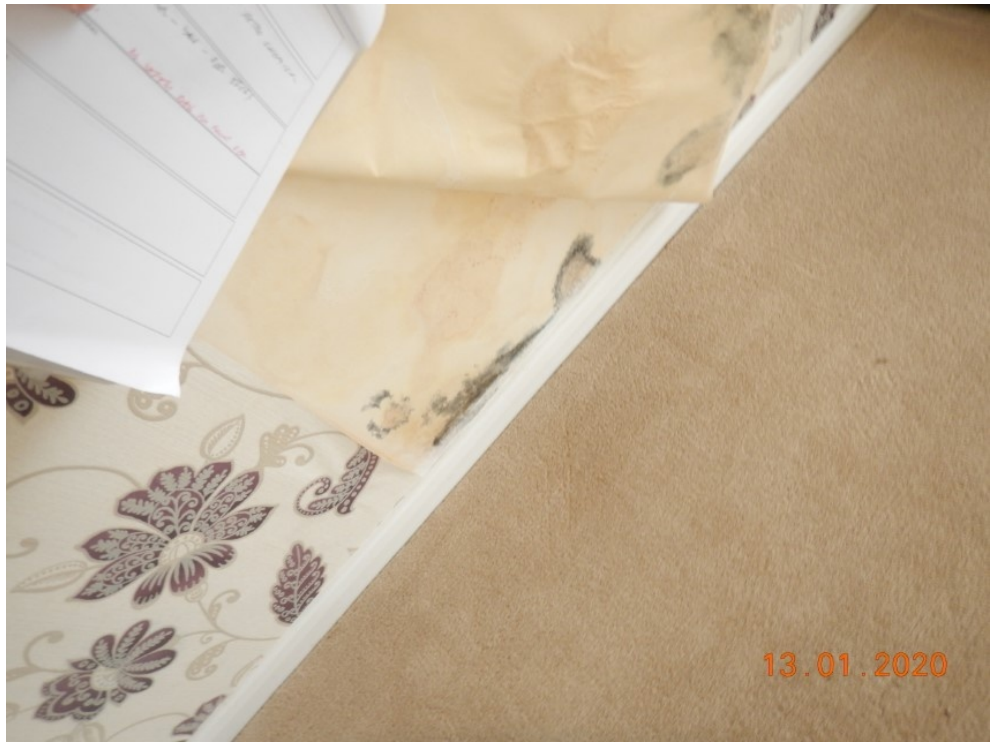
Reception room 1 (right of front door)  
the is the same wall as the chimney  
breast

Damp to most walls

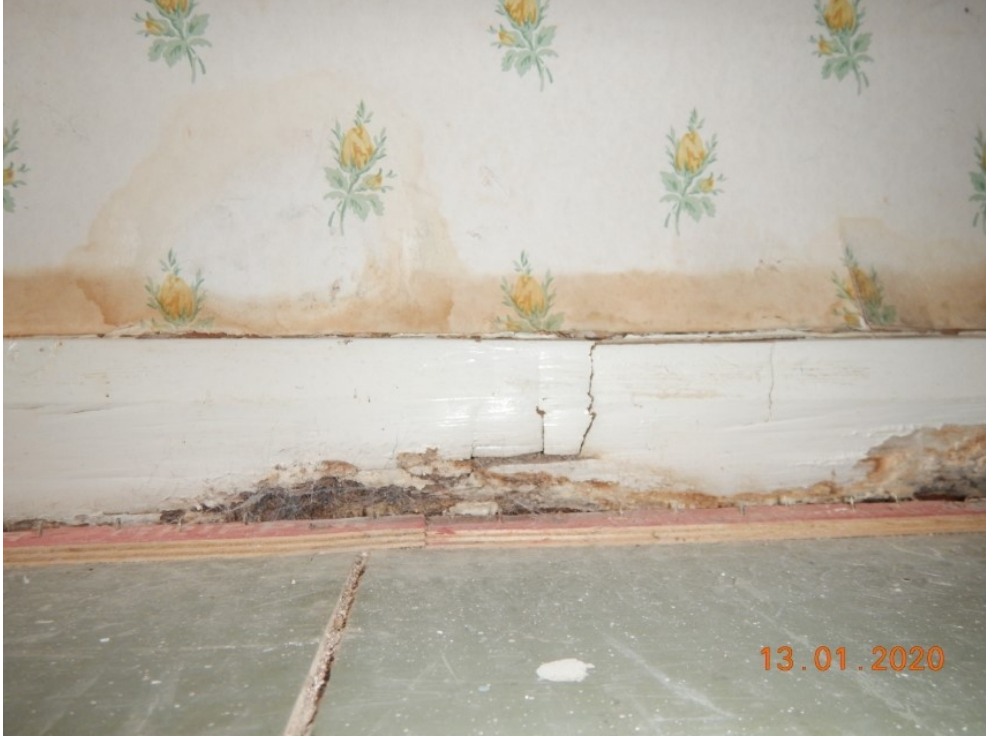
## Bedroom 2, left hand wall

<b>Condition</b>	<p>Dry rot is affecting the skirtings where the rising damp is at its worse.</p> <p>All doors within the property were found to open and close without fouling on their frames, suggesting that no unusual movement of the structure has occurred since the doors were installed.</p>
<b>Action Required</b>	<p>Affected timbers need removal and areas treated to prevent spread.</p> <p>Door hinges and locks should be regularly lubricated. Internal timbers should be inspected regularly for evidence of bowing or distortion, woodworm and other defects.</p>

<p style="text-align: center;">dry rot to skirting</p>

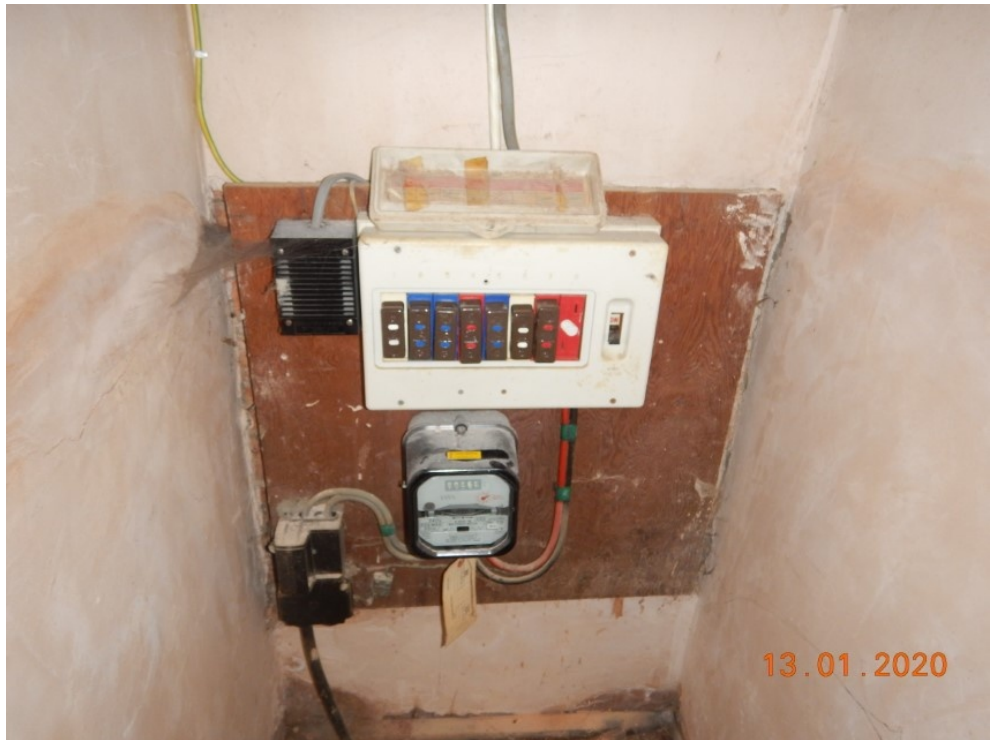
old fuse board

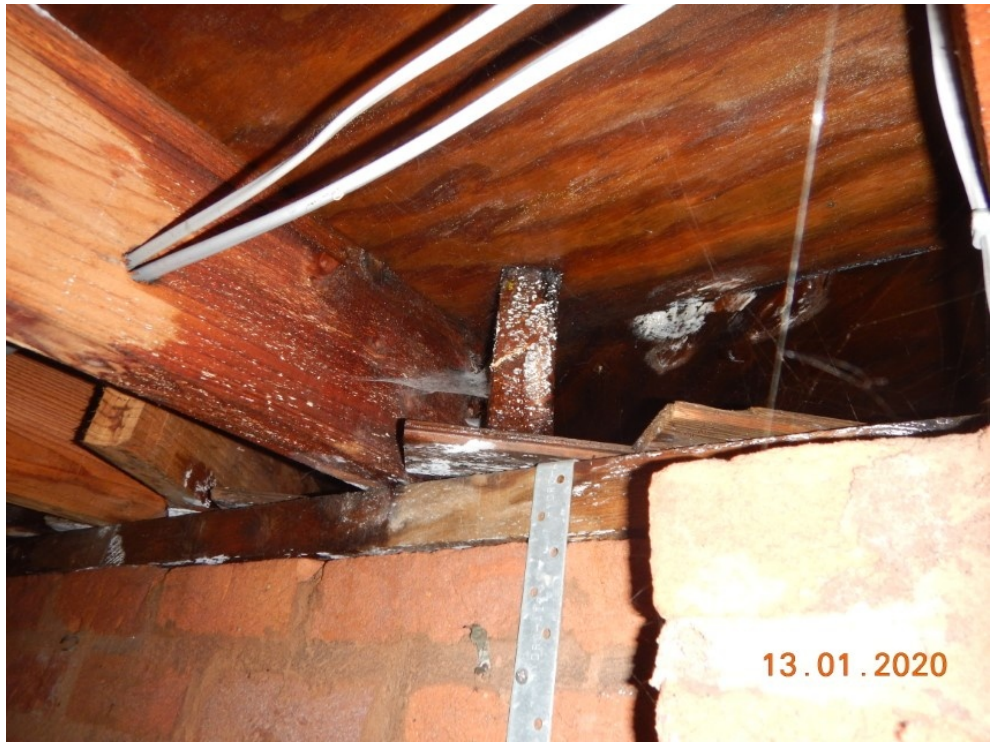
<b>Condition</b>	The structure although currently sound it has been subject to long term rain ingress so walls are saturated and roof timbers are starting to rot.		
<b>Action Required</b>	Renew roof covering and check and replace timbers as required.

rot caused by leaking flat roof

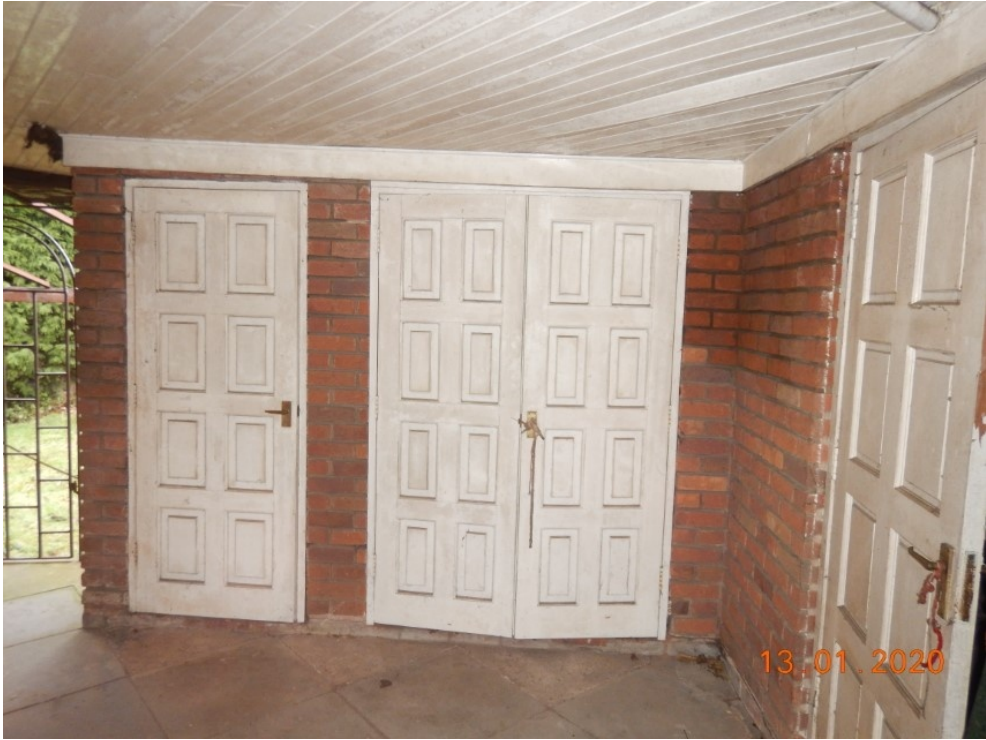
<p data-bbox="780 1588 1037 1617">external store rooms</p>

7.2 Outbuildings and Sheds	Condition rating	3
<b>Construction &amp; Type</b>	The garage joins the bungalow via a covered area with a timber clad ceiling and to cupboards with timber doors.		
<b>Nature of inspection and Limitations</b>	The area was assessed for general condition and was examined externally and internally to identify areas of rot, damage, leaks and other defects.		
<b>Condition</b>	The roof cladding is starting to fail due to rain ingress and doors all need easing.		
<b>Action Required</b>	Once roof renewed, cladding needs repair and redecoration and doors need easing.

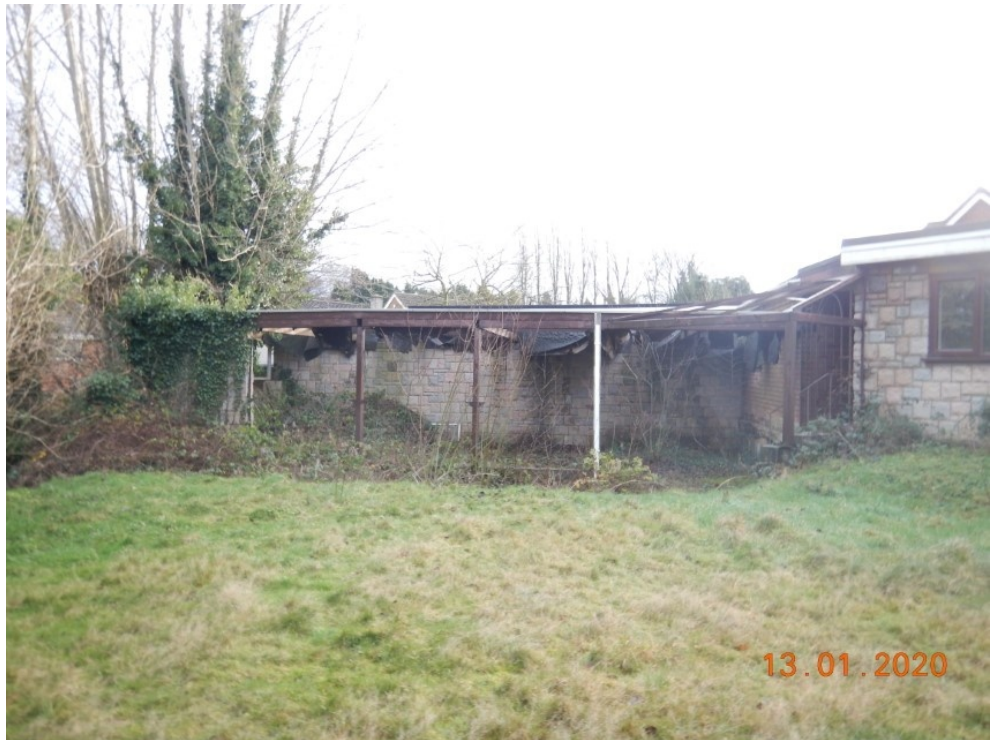
<b>Condition</b>	<p>The garden has been poorly maintained, there is a derelict steel frame structure and the concrete driveway is worn with some areas breaking down.</p>		
<b>Action Required</b>	<p>Full Maintenance is Required.</p>

derelict metal frame structure

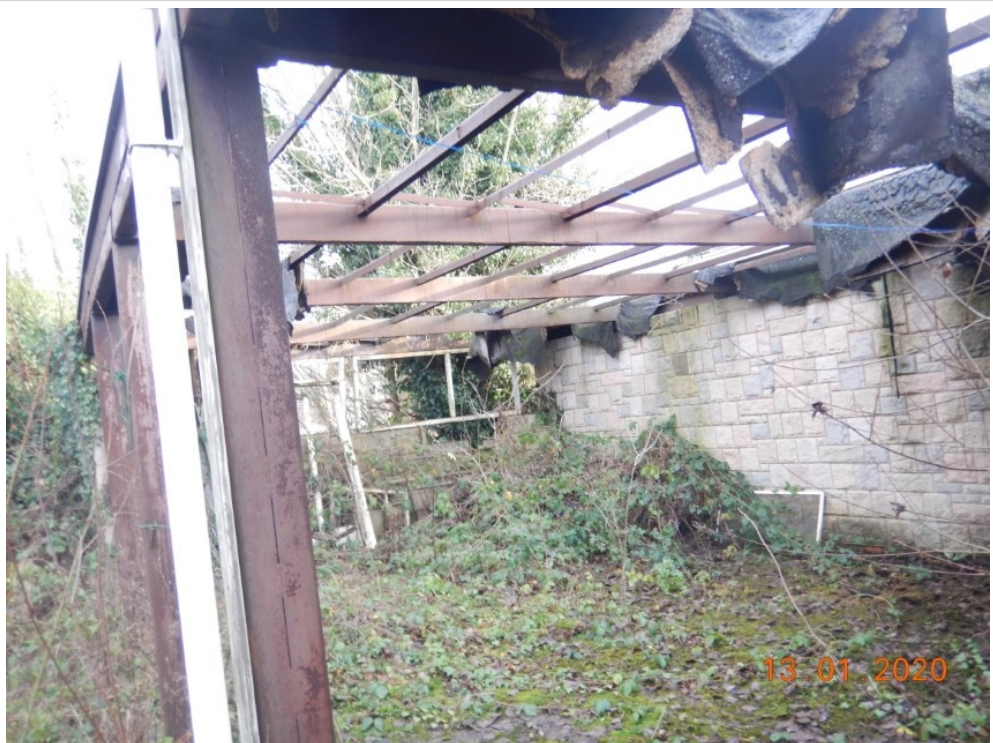
derelict structure
