Damp Specialist Findings and suggested Solutions:

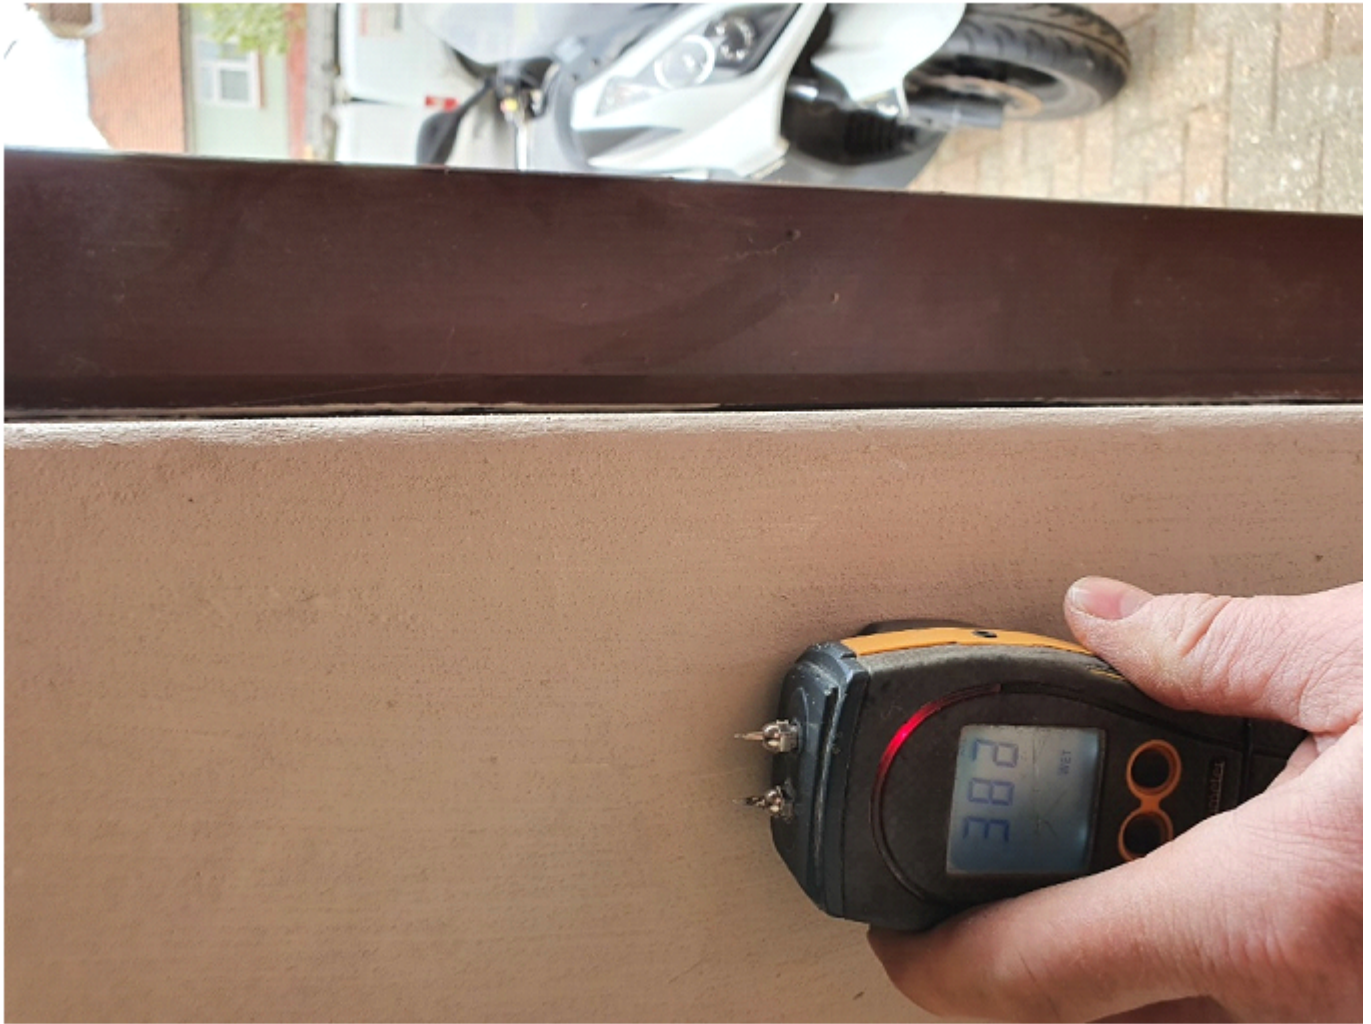
High moisture readings to the side garage external wall this has been caused by the high external ground levels to the neighbors adjoining wall, the neighbors garage roof is also sloping towards the property and does not look like the wall has been protected properly, I understand this is being addressed by a roofer who was on site when I visited the property, the internal wall in the garage will need damp proofing by raising the new damp course and using tanking due to the high ground levels tanking is usually used in basements but due to the high ground levels it will be needed to damp proof this wall, moisture readings were taken throughout the living areas of the property and no high moisture readings were found, I will attach separately photographs of the readings found.

High reading at front of garage.

To be carried out as per our treatment method for rising and penetrating damp as shown on the plan of works, we will need to raise the new damp course and apply tanking at low level.
