- A Introduction to the report
- B About the inspection
- C Overall opinion and summary of the condition ratings
- D About the property
- E Outside the property
- F Inside the property
- G Services
- H Grounds (including shared areas for flats)
- I Issues for your legal advisers
- J Risks
- K Surveyor's declaration
- What to do now
- Description of the RICS HomeBuyer (Survey) Service
- Typical house diagram

21 Rounds Road, Bilston, West Midlands, WV14 8TD

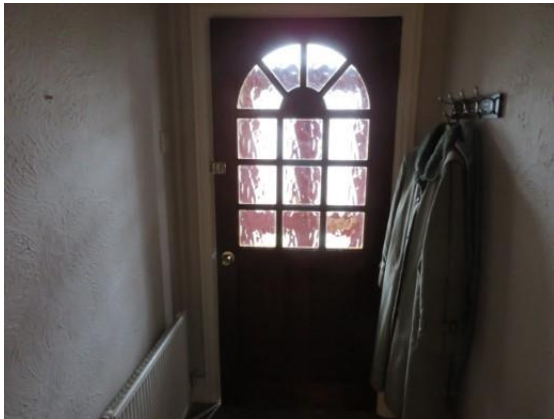
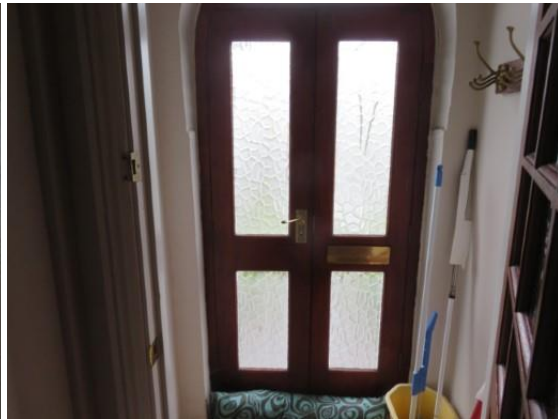
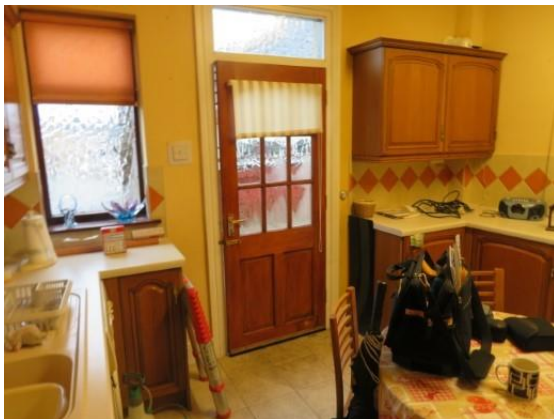
At the front and side of the property timber panel single glazed doors. The doors were checked for normal operation. The kitchen door sticks in the frame due to seasonal expansion/contraction of the wood. No significant defects were noted.

(Condition Rating 1).

Single glazing is a safety hazard. (See section J3).

You may wish to consider upgrading the door with modern PVC equivalent doors to help provide better safety, security and thermal performance.

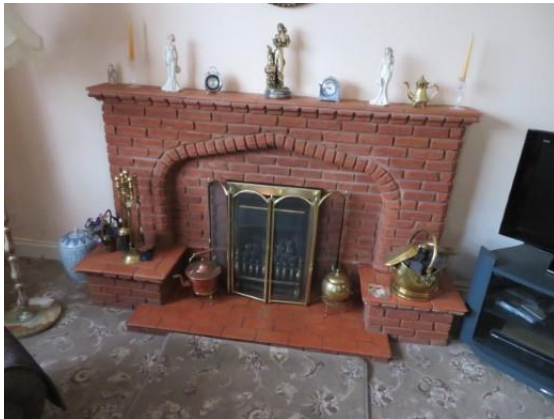
The chimney breast and stack above at the rear of the original house has been removed. Although I did not see any problems, you should ask your legal adviser to check whether the local council has granted building regulation approval for this work (see section I1).

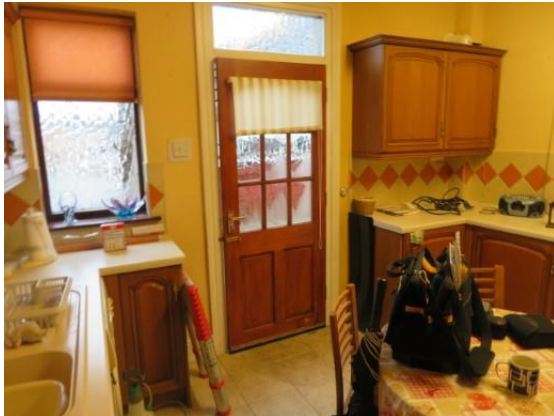
There is no mechanical means of extraction to the outside. The lack of mechanical extraction can cause condensation within such rooms due to changeable temperatures, increased periods of humidity and lack of ventilation. Although there was no evidence of condensation this could change due to changes in occupancy levels and lifestyle. In order to assist in preventing condensation in the future you may wish to consider engaging a suitably qualified electrician to fit an extraction unit and to connect ducting to the outside.

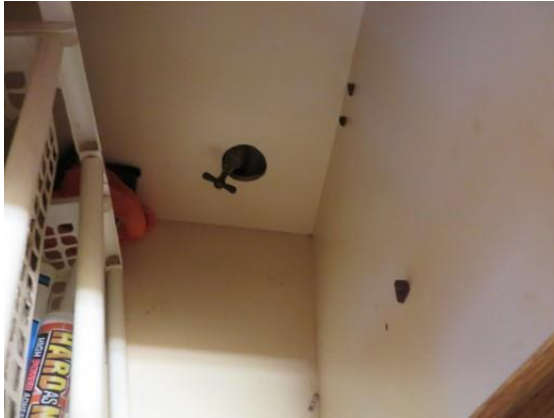
The property is heated by a Worcester condensing, system gas central heating boiler housed in a cupboard in the kitchen. A secondary form of heating is supplied by the gas fire in the sitting room.

Where a fixed combustion appliance (boiler, gas fire etc...) is provided, appropriate provision should be made to detect and give warning of the release of carbon monoxide, therefore, I would recommend the installation of carbon monoxide alarms in rooms with such appliances. Alarms should be installed in accordance with British Standard EN 50292 and the manufacturer's instructions.

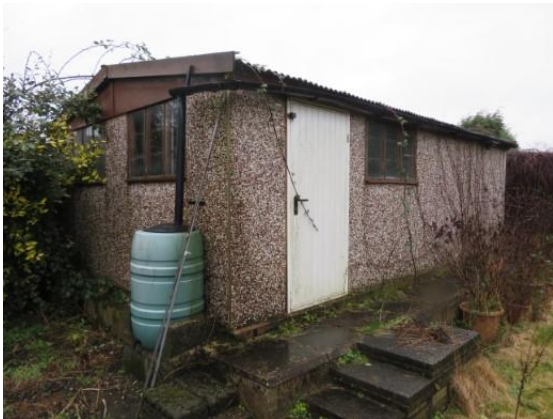
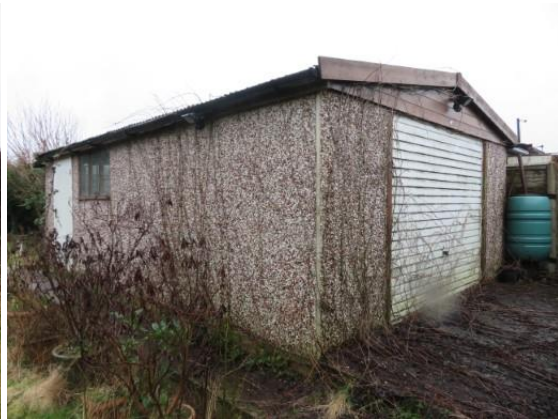
The garage is generally satisfactory.

(Condition Rating 1).
