# BUILDING SURVEY REPORT

SURVEY DATE 13 Jan 2020

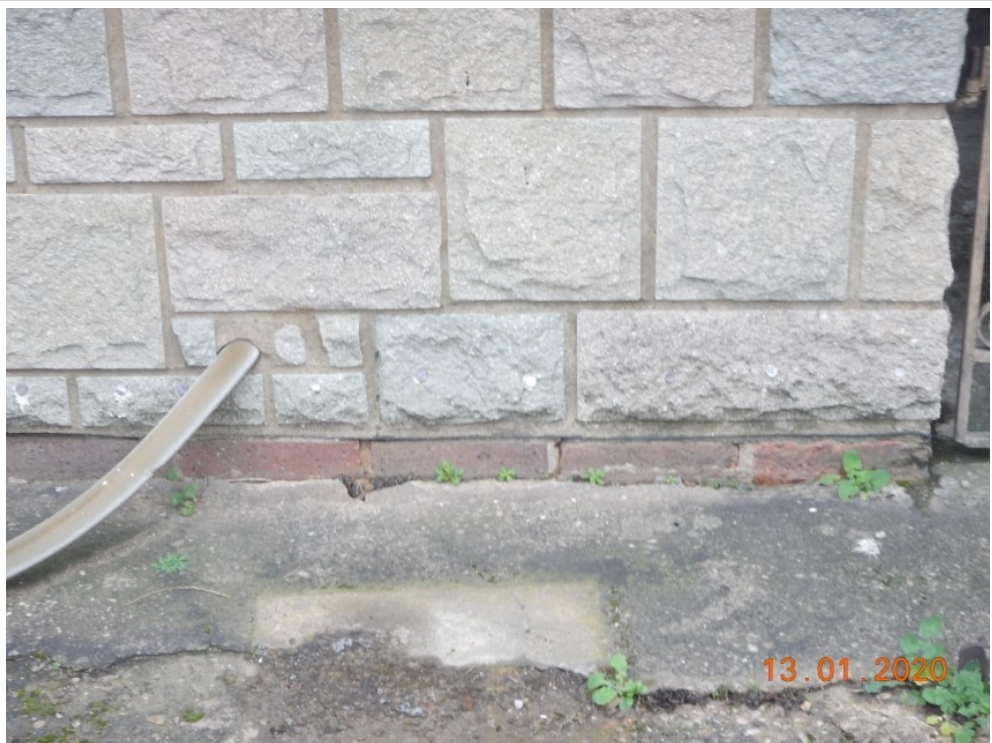
stone cladding

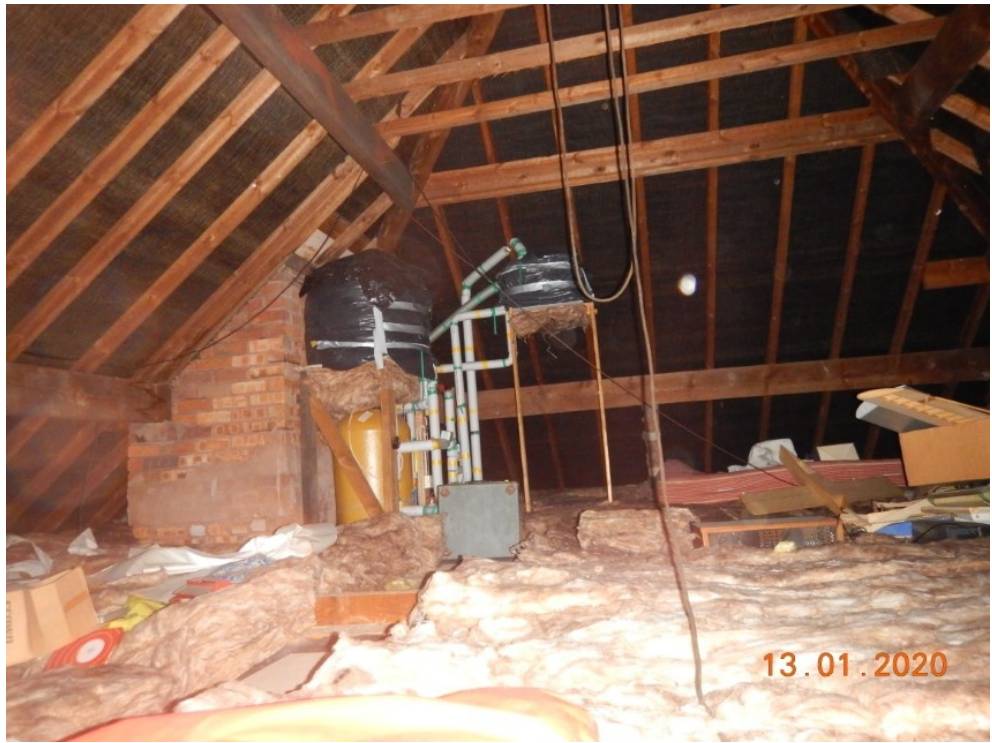
<b>Condition</b>	<p>The roof structure is in a good condition with no evidence of structural failure or unusual movement. The rafters, purlins and strut timbers are complete with no evidence of any undue stress or cracking. The bitumen undercovering (secondary waterproof covering) is complete with no major tears or missing sections.</p> <p>No significant defects were noted during my inspection and the roof was found to be structurally sound. No evidence was seen of any unusual movement or stress of the supporting timbers within the roof, and there have been no obvious significant alterations to the structure which might have resulted in it becoming substantially weakened. No evidence was seen of infestations by wood boring insects (commonly known as "woodworm"), other insects, birds, rodents or bats.</p> <p>The roof space is laid with about 150mm of wool type insulation at joist level. Increasing the thickness to the current recommendation of 270mm is recommended for increased energy efficiency, but when adding insulation it is important to maintain good ventilation within the roof space and not to block ventilation grills or openings.</p>

underfelt in good order

<b>Action Required</b>	<p>Regularly monitor timbers, at least twice a year, for evidence of wood boring insects and other such infestations.</p>

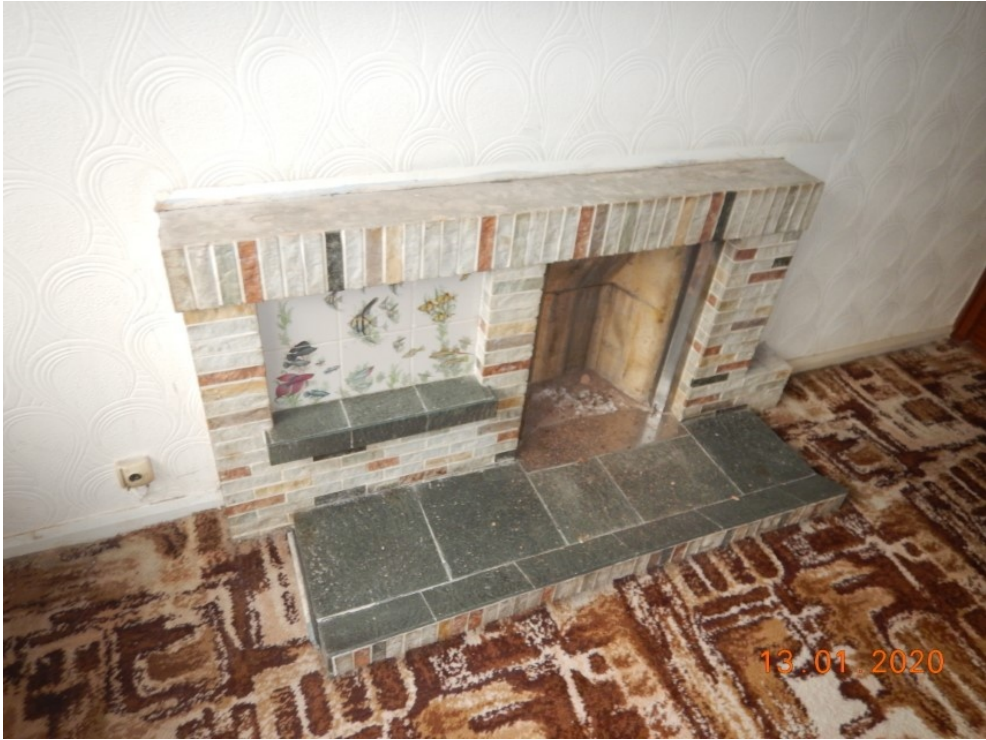
<p>Open fireplace to sitting room</p>

**This is the other side to the kitchen**

<b>Action Required</b>	<p>All active flues should be checked by a reputable heating engineer specialising in flues and chimneys, prior to use. Flues should also be swept clean at this time.</p> <p>It is important to maintain an adequate airflow, by means of ventilation, through unused chimney flues to prevent the build-up of condensation within the chimney. Ventilation grilles should be fitted to all blocked breasts.</p>

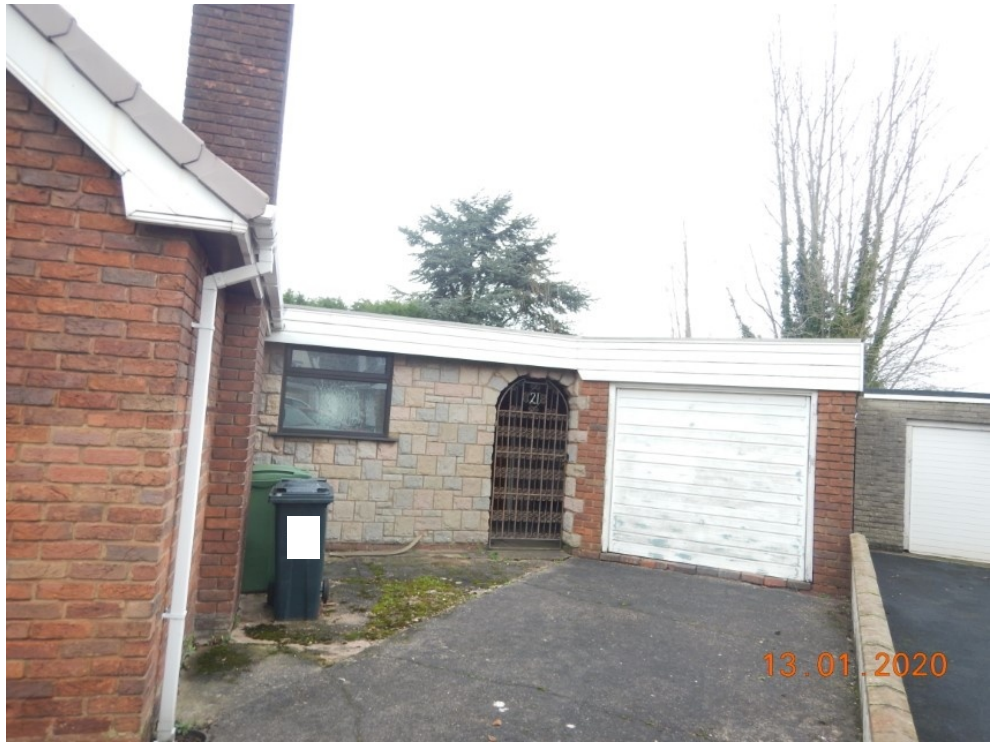
garage

<b>Condition</b>	The structure although currently sound it has been subject to long term rain ingress so walls are saturated and roof timbers are starting to rot.		
<b>Action Required</b>	Renew roof covering and check and replace timbers as required.

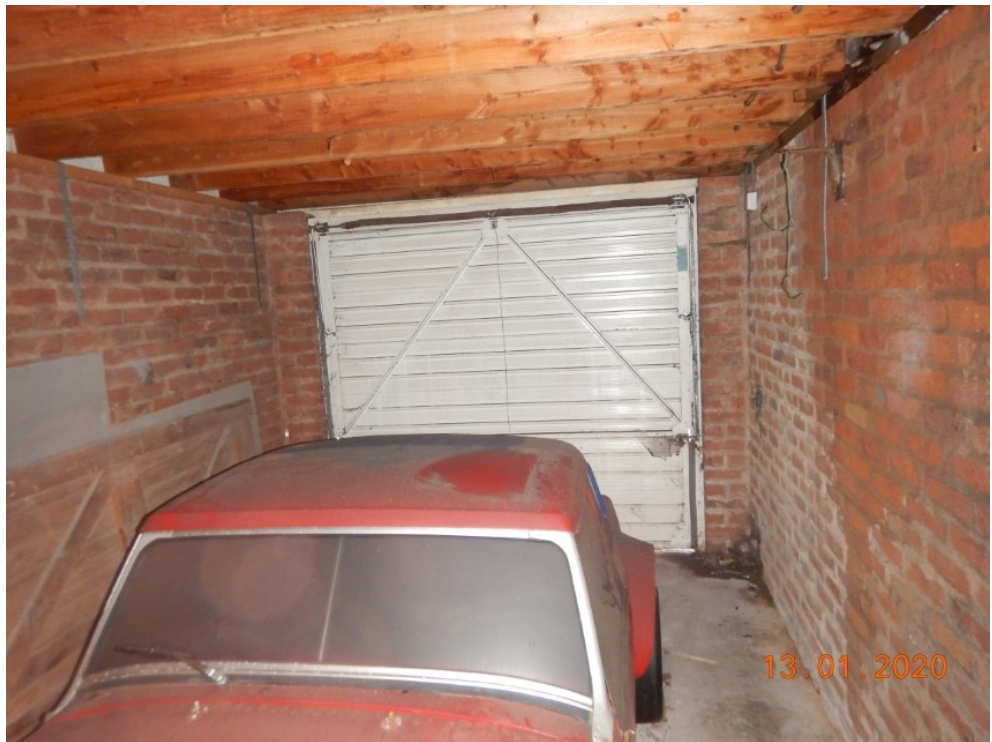
View inside garage
